A STUDY IN SERVICE LIFE

Fairplay, CO

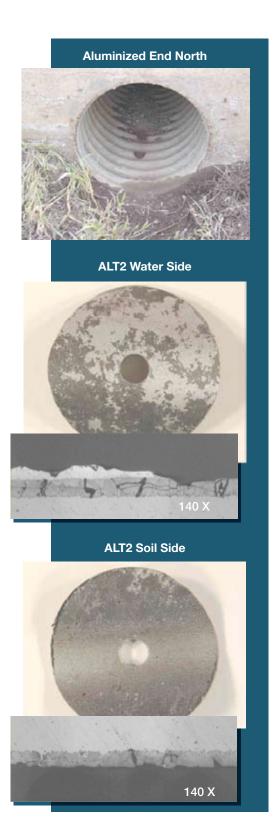
24" diameter ALT2 in very good condition on both ends with concrete headwalls; free aluminum coating is visible around the complete circumference; previous trepan holes were not corroded further; sample taken at 6 o'clock position.

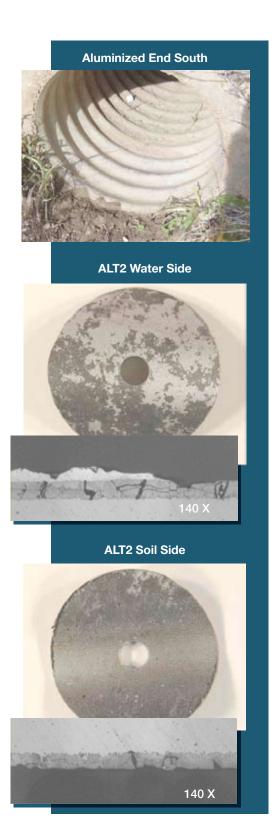
Coupons were bead blasted to remove loose oxides and images were recorded of the remaining surface (see images on right). Micrometer readings were taken after bead blasting using a ball micrometer (general thickness) and a point micrometer (deepest pit depth).

Micrometer Results – Ball: 0.065", 0.065", 0.064" **Point:** 0.059"

(0.007" deep - few small pits)
