TO: W. S. Anders
FROM: W. E. Harrison
SUBJECT: Blue Ridge Parkway Culvert Survey

A STUDY OF BITUMINOUS-COATED CORRUGATED SHEET METAL CULVERTS

BY THE DIVISION OF PHYSICAL RESEARCH, PUBLIC ROADS ADMINISTRATION

Reported by J. Y. Welborn, Associate Highway Engineer, and P. J. Serafin, Assistant Chemical Engineer

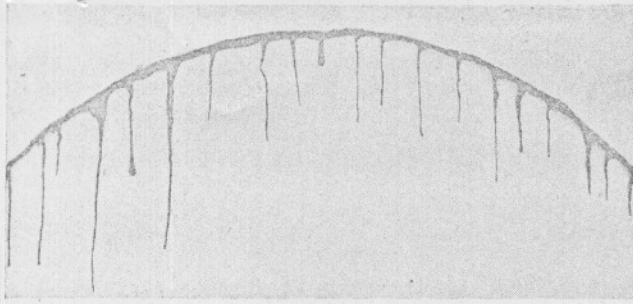
FIGURE 1.—TYPICAL CONDITION OF FLOW FROM CRESTS OF CORRUGATIONS IN THE TOP QUARTER INSIDE THE CULVERT PIPE.

Flow.—In some culverts a displacement of the asphalt coating by flow was noted. This condition occurred at the top of the pipe and was in the form of strings of asphalt hanging from the crests of the corrugations. Flow is illustrated in figure 1, which shows the coating cut from the corrugations, reassembled, and photographed.

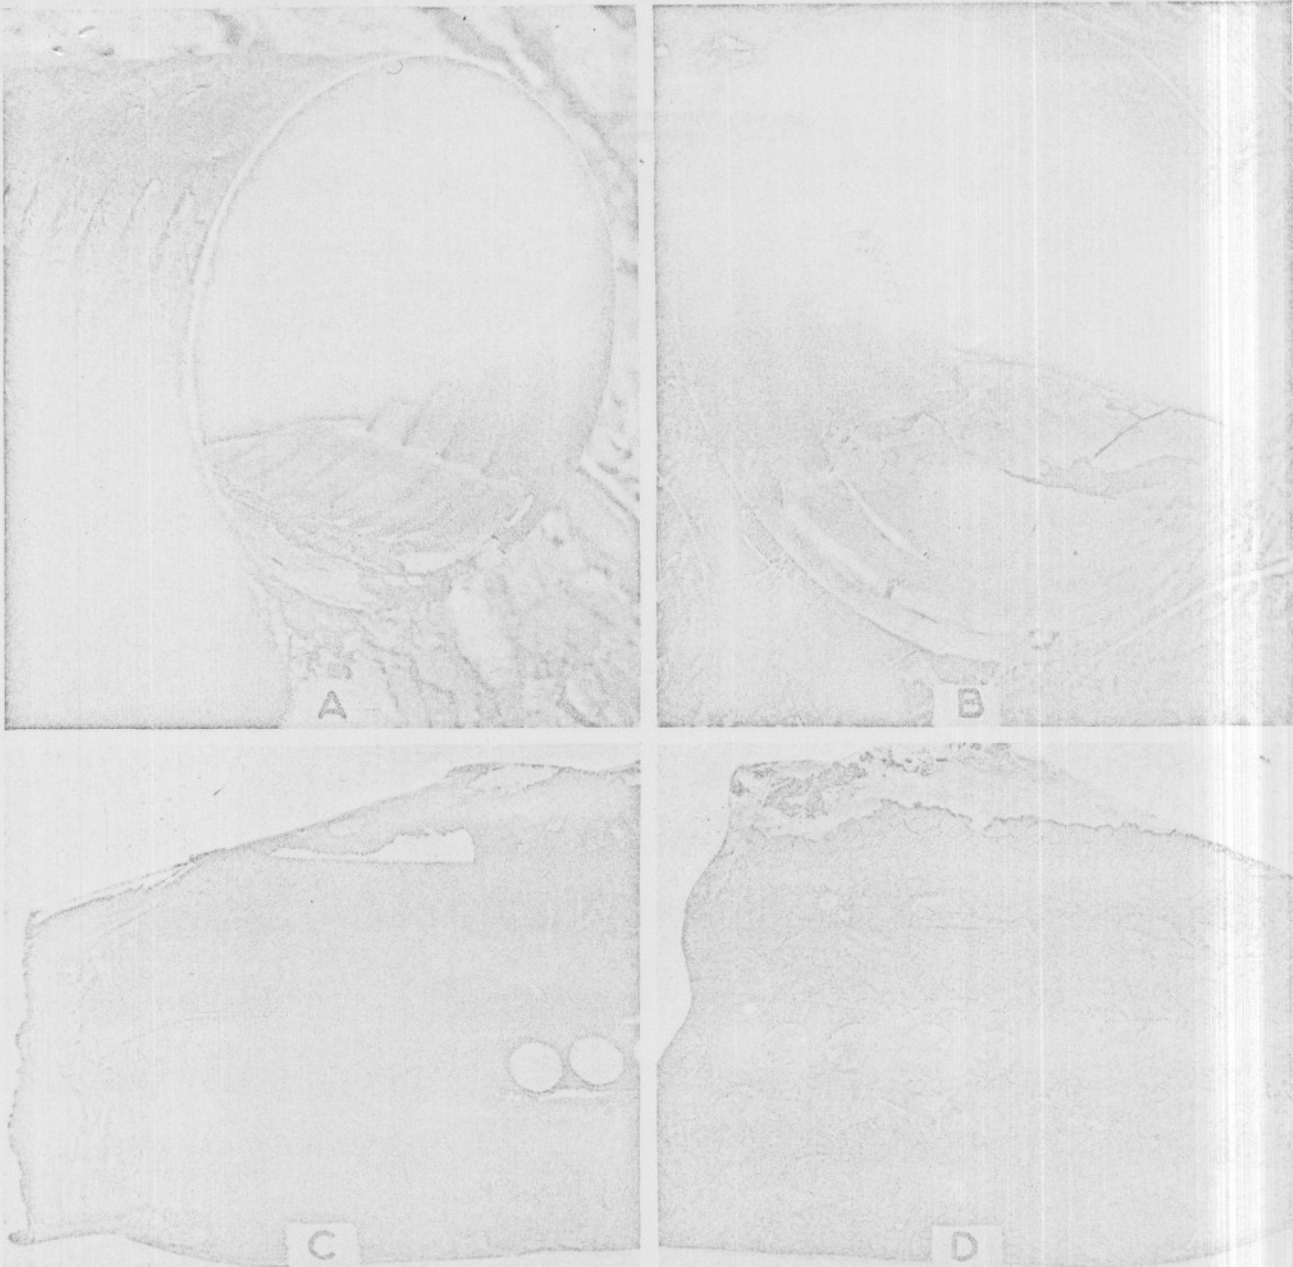
FIGURE 2.—BITUMINOUS-COATED GALVANIZED METAL PIPE: (A) SEVERE LONGITUDINAL CRACKING; (B) CRACKING OF ASPHALT PAVEMENT; (C) INSIDE VIEW OF SAMPLE CUT FROM OUTLET END OF PIPE. CONDITION APPEARS TO BE GOOD BUT ADHESION TEST (ROUND SPOTS) SHOWS LOW ADHESION; AND (D) OUTSIDE OF SAMPLE SHOWN IN (C). THIS PORTION OF THE PIPE WAS IN CONTACT WITH SOIL. TESTS SHOWED POOR ADHESION.

were inspected. The pavements in 7 culverts were rated good, 4 were checked, 13 were cracked only, and 2 showed sufficient loss of coating to expose the metal. Typical conditions are shown in figure 2.

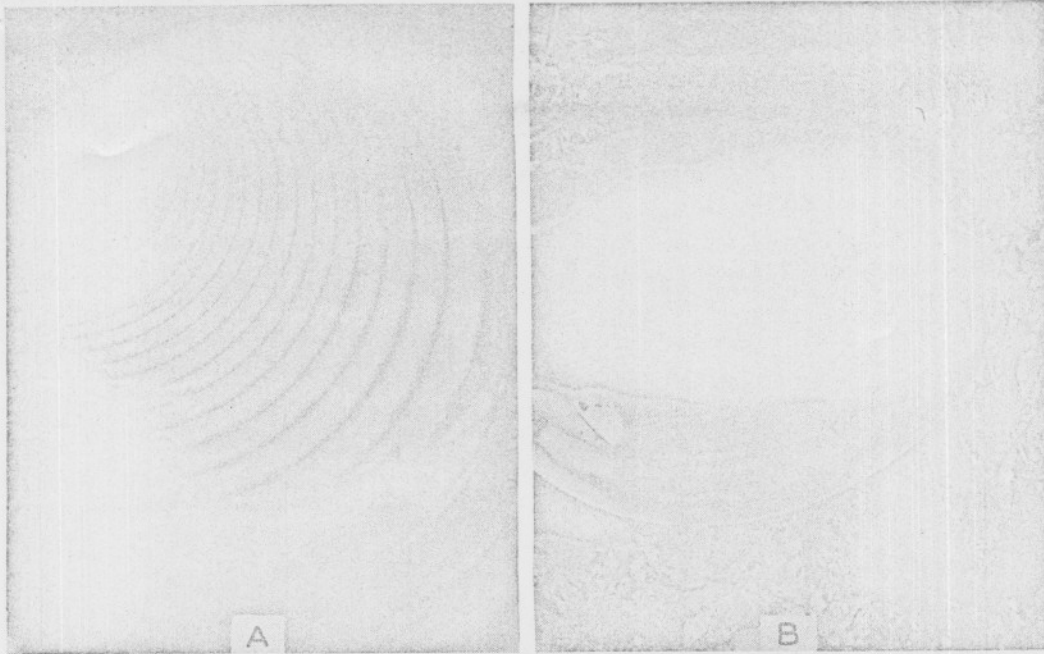
FIGURE 3.—A, ASPHALT COATING STRIPPED FROM WALL BY WATER SURGING THROUGH THE CULVERT ON 47 PERCENT GRADE; B, LOSS OF PAVEMENT FROM SAME CULVERT WITH RUSTING OF EXPOSED METAL.

The inside coatings above the inverts also showed more deterioration than on section 2M-1. For 6 of the 11 culverts inspected the coatings were good, 1 was checked only, and 4 showed some loss of coating. One culvert, which had an extremely high loss of coating on the inside walls, is of special interest. This culvert was installed on a 25° skew on a grade of 47 percent with a head wall at the inlet end. It appeared that during heavy rainfall water ran down the gutter and into the pipe at high velocity. It struck the side of the pipe above the pavement at an angle and had stripped a large area of the asphalt coating from the side wall. This condition was repeated on alternate right and left sides of the pipe for a considerable distance down the pipe. Figure 3, A shows the high loss of coating from the inside wall near the inlet. The loss of asphalt coating from the pavement is illustrated in figure 3, B.

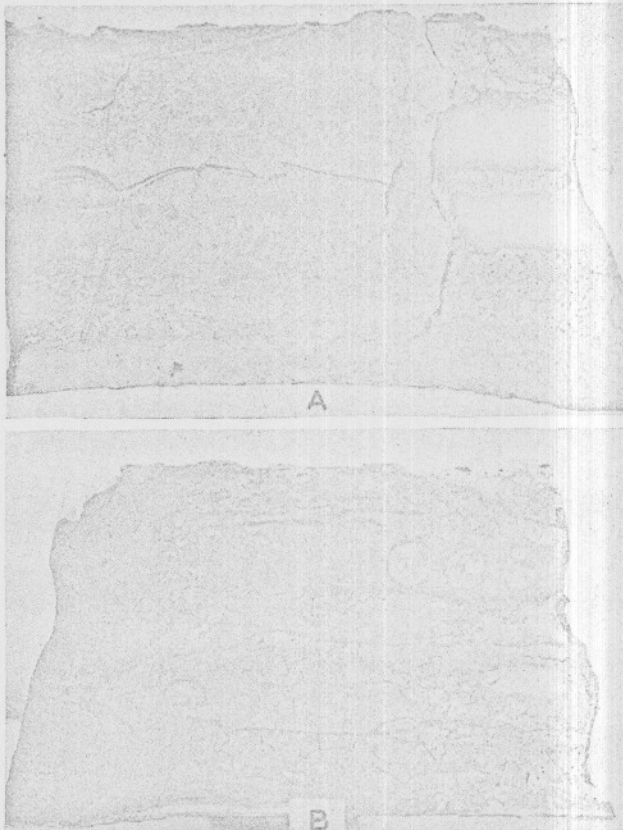
Typical conditions of the culvert pipe installed on sections 2M-2 and 2N-1 are shown in figures 4 and 5.

FIGURE 5.—SAMPLE TAKEN FROM OUTLET END OF BITUMINOUS-COATED ASBESTOS-BONDED METAL PIPE. (A) INSIDE SHOWS CRACKED PAVEMENT; (B) OUTSIDE SHOWS GENERAL CONDITION OF COATING WHICH HAS BEEN IN CONTACT WITH SOIL SURROUNDING CULVERT.

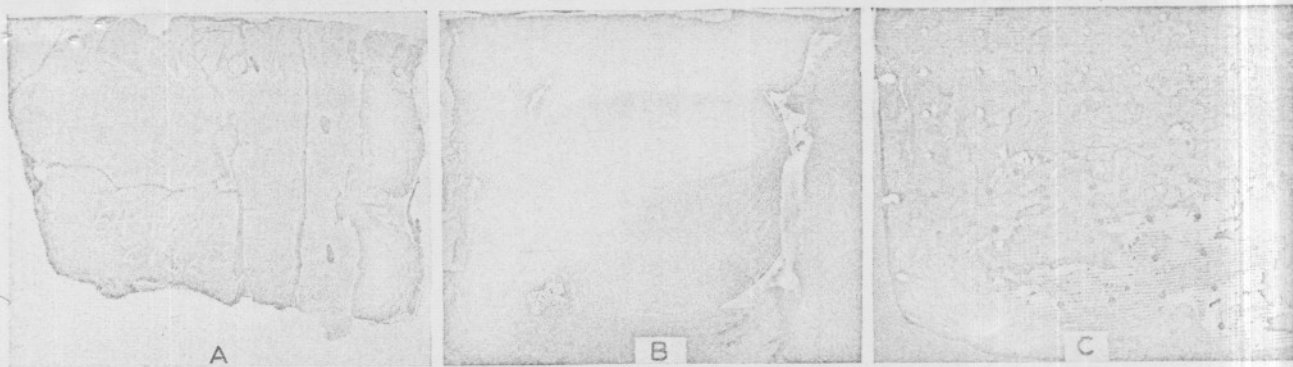
The conditions of some of the culvert pipe installed on sections 2N-2, 2P-1, and 2V-1 are illustrated by figure 6.

FIGURE 6.—METAL-REINFORCED ASPHALT PAVING. (A) SAMPLE FROM OUTLET END SHOWING LOOSENING OF REINFORCEMENT; (B) COATING ON REINFORCING PLATE BADLY BROKEN WITH SOME LOSS; AND (C) SECTION OF REINFORCING PLATE SHOWING LOSS OF COATING AND RUSTING OF EXPOSED METAL.
