# **Polymeric Coated Corrugated Steel Pipe Durability Study** **Update: October 27, 2016**

**Field Performance of Polymer Coated CMP**  
**Cass County Minnesota**  
**State Hwy 84 Pine River, MN to Longville, MN**

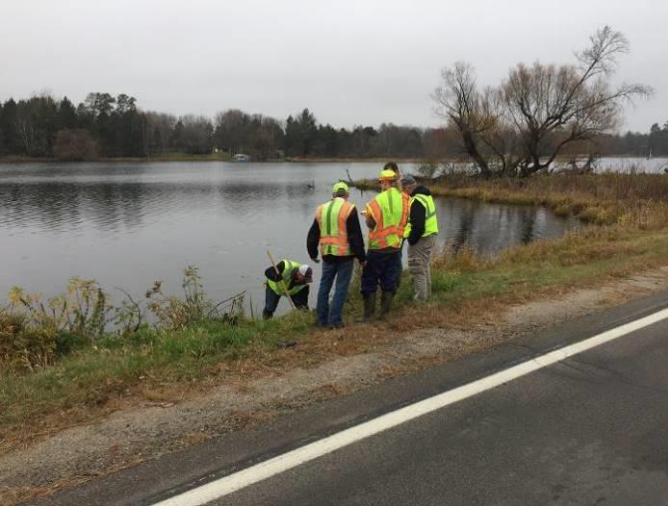
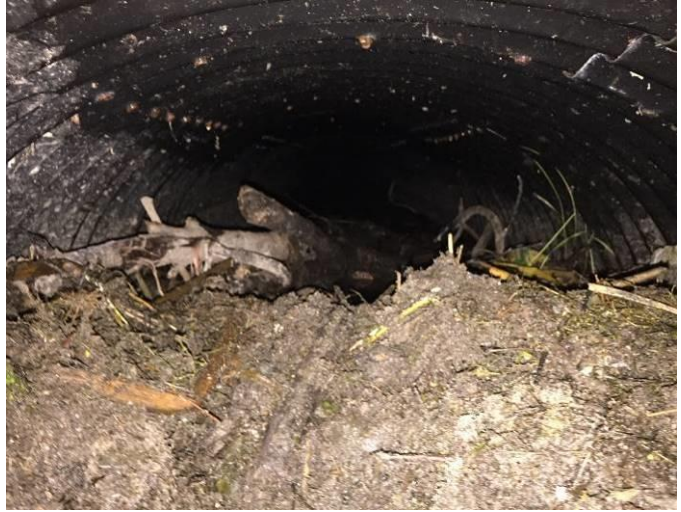
**Location #1** at mile post 0.60 – single 28” X 20” Pipe Arch Shape

Pipe Rating – Unknown 0 (Not able to rate, not visible). Most of the pipe was submerged with beaver dam on the downstream end. The top of the culvert was visible and looked in good condition.

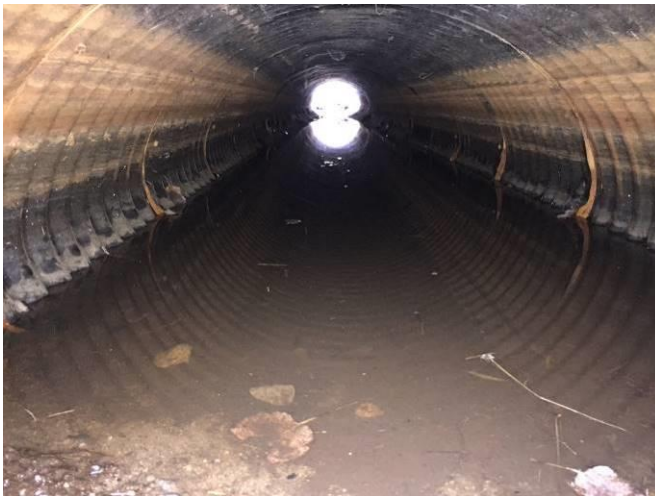
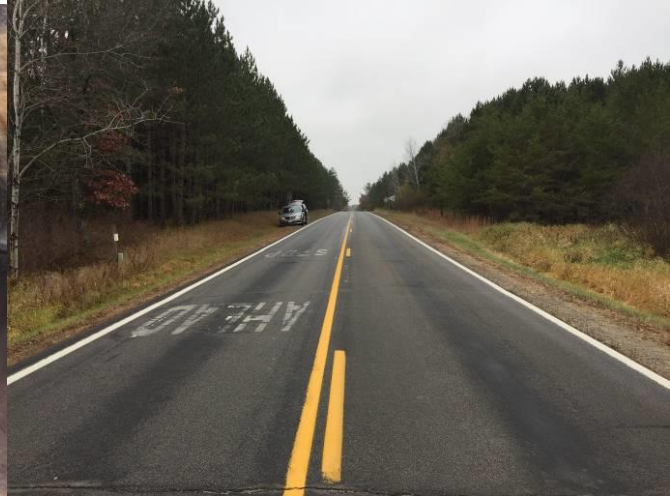
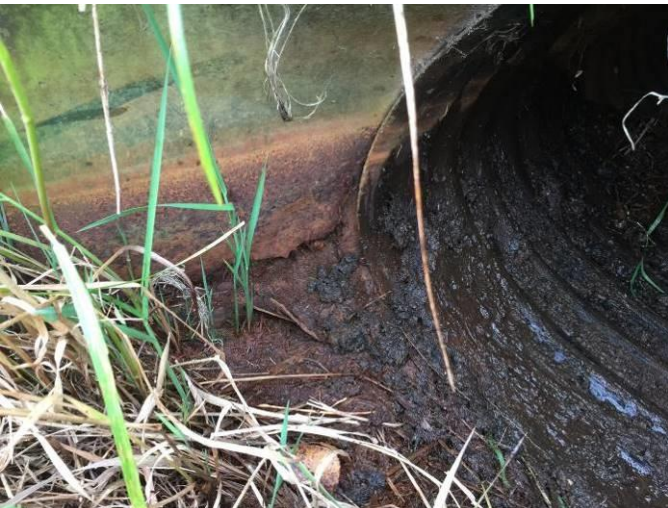
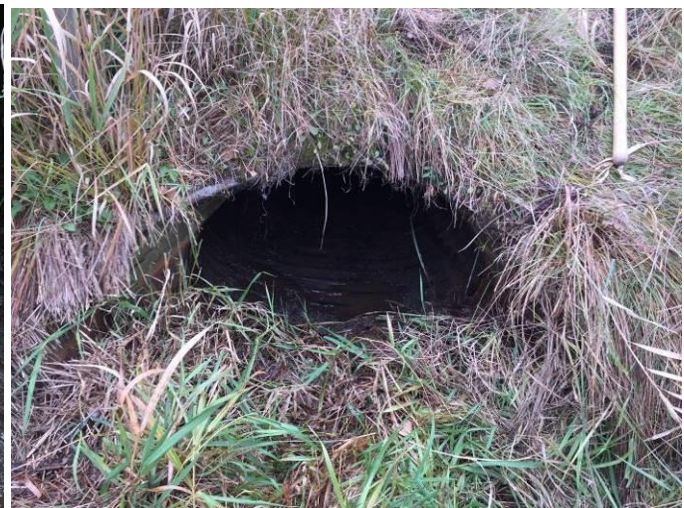
**Location #2** at mile post 2.60 – 35” X 29” Pipe Arch Shape

Pipe Rating – Still Okay 2 (Fair - some wear, but structurally sound) Site was wet with some standing water in the pipe culvert. The outlet end required cleaning. The galvanized end section was rusted through. The polymer culvert was in good shape with minor delamination at a few riveted seams.

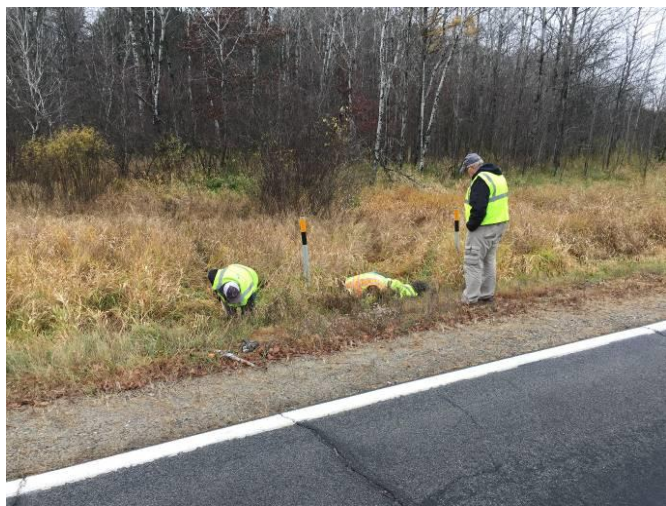
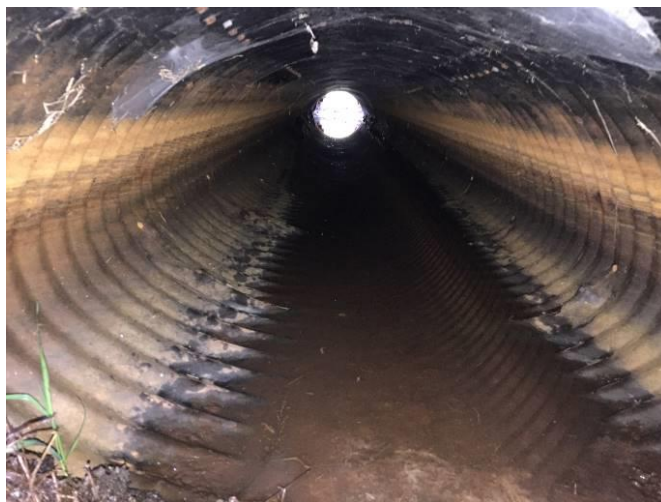
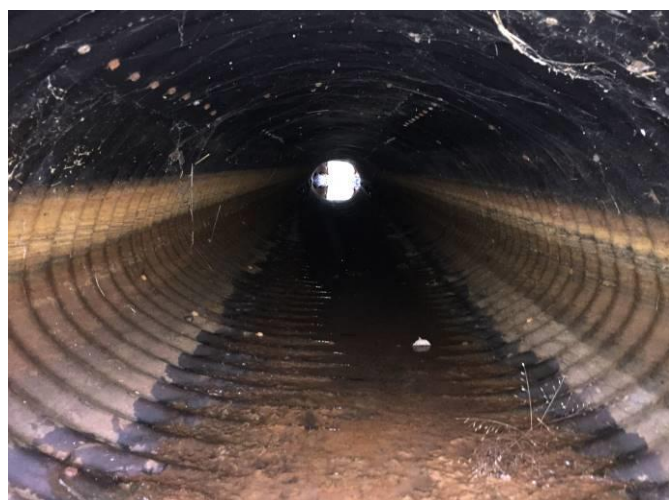
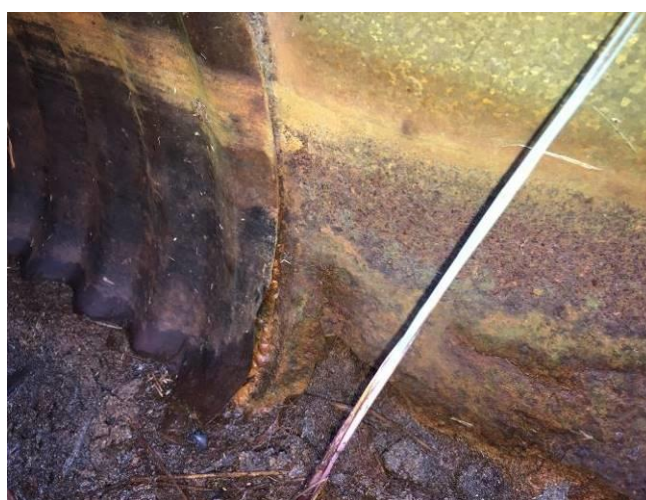
**Location #3** at mile post 2.61 – 35” X 29” Pipe Arch Shape

Pipe Rating – Still Okay 2 (Fair - some wear, but structurally sound). The site was wet with some standing water in the pipe culverts. The galvanized end section was rusted through. The polymer culvert was in good shape with minor delamination on the inlet end.

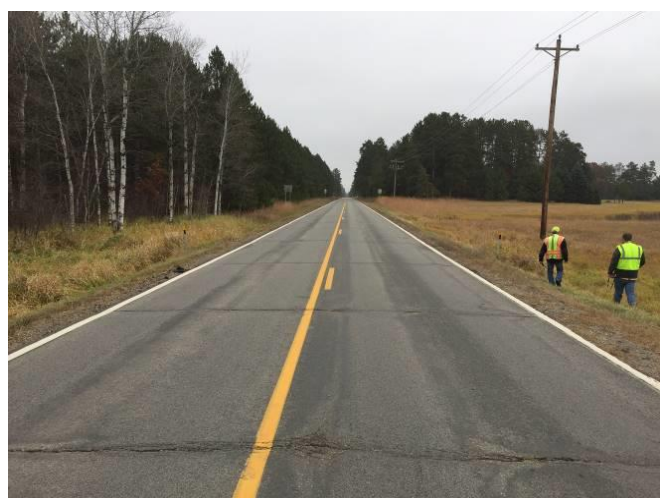
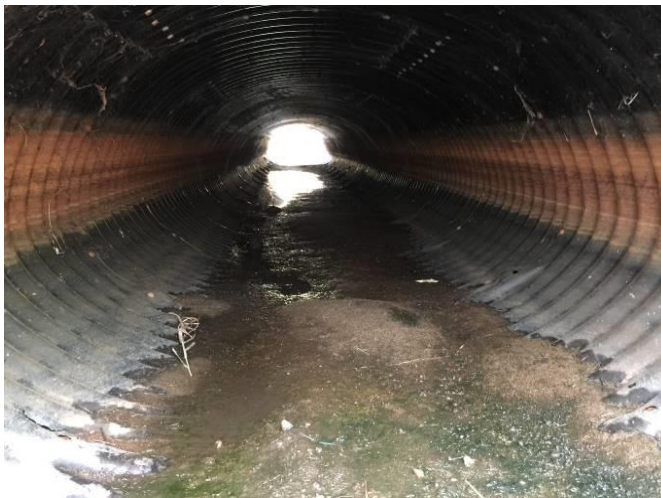
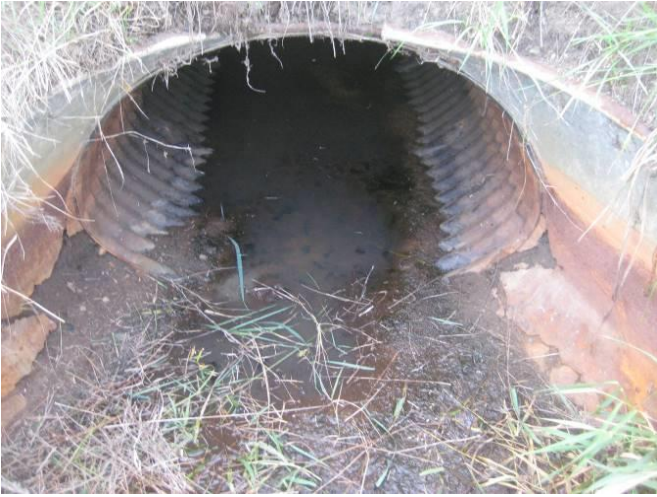
**Location #4** at mile post 2.73 – 42” X 29” Pipe Arch Shape

Pipe Rating – Still Okay 2 (Fair - some wear, but structurally sound). The pipe appeared to be in good shape with minor delamination at a few riveted seams. The galvanized end section was rusted through.

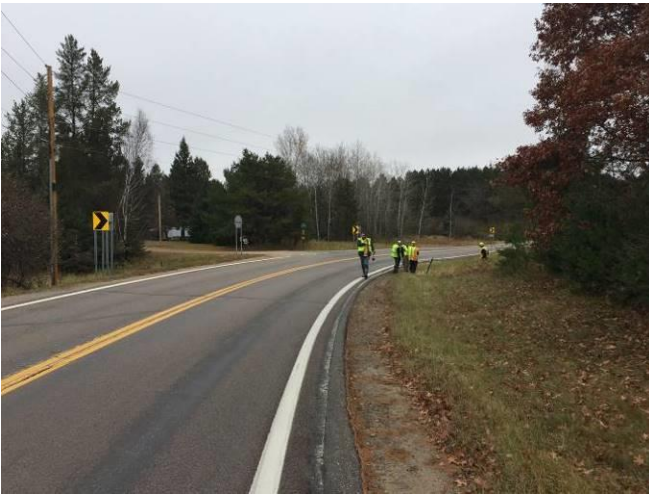
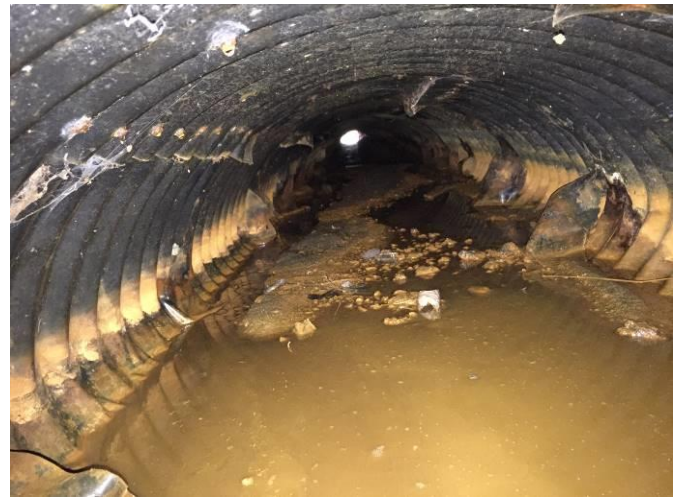
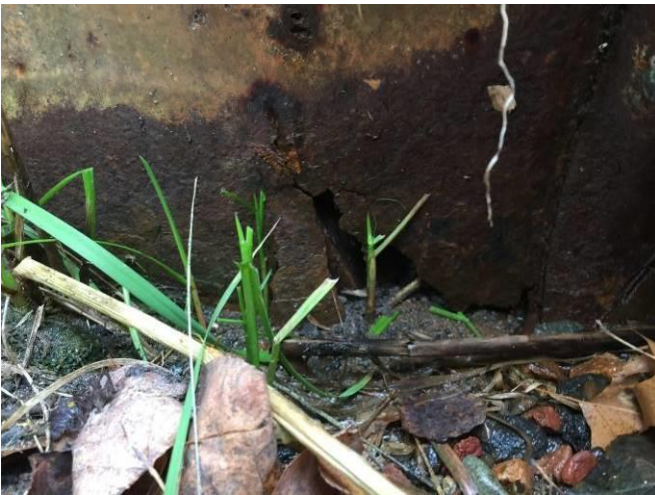
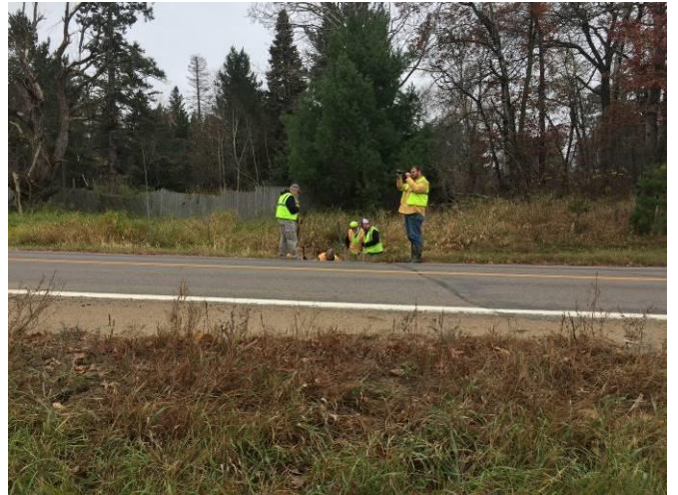
**Location #5 at mile post 12.81 – 28” X 20” Pipe Arch Shape**

Pipe Rating – Still Okay 2 (Fair - some wear, but structurally sound). There was delamination throughout the culvert, however no perforations were in the base steel of the culvert. The galvanized end section did show corrosion with pitting through the steel.

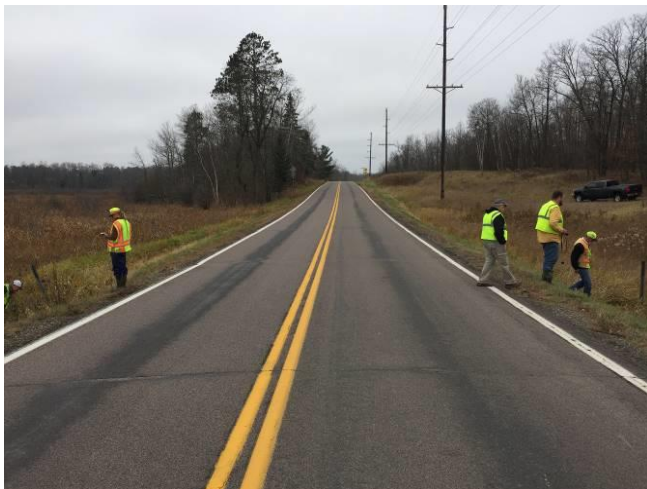
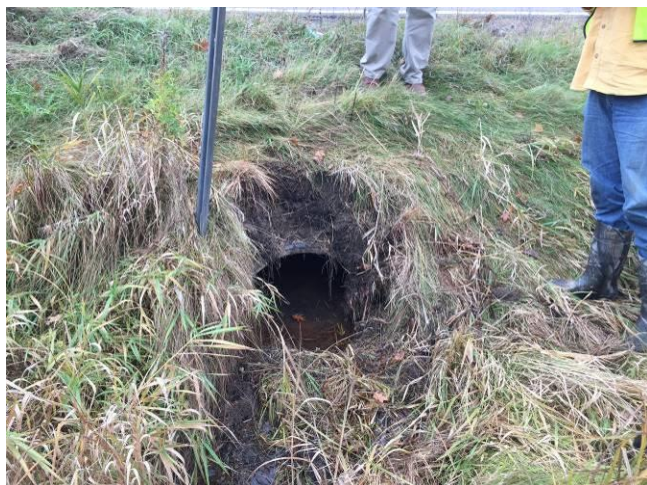
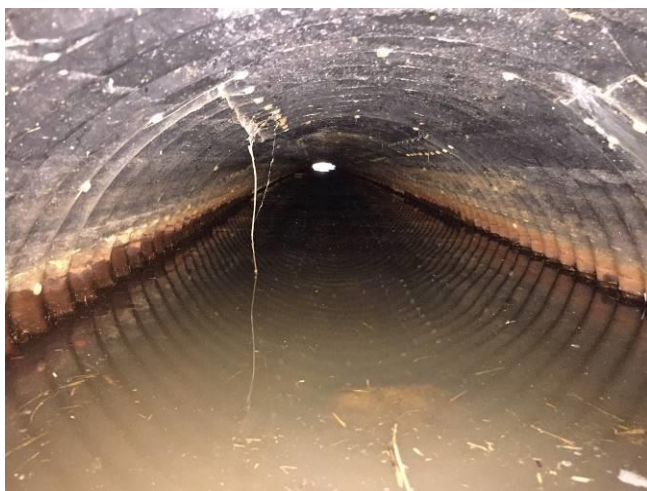
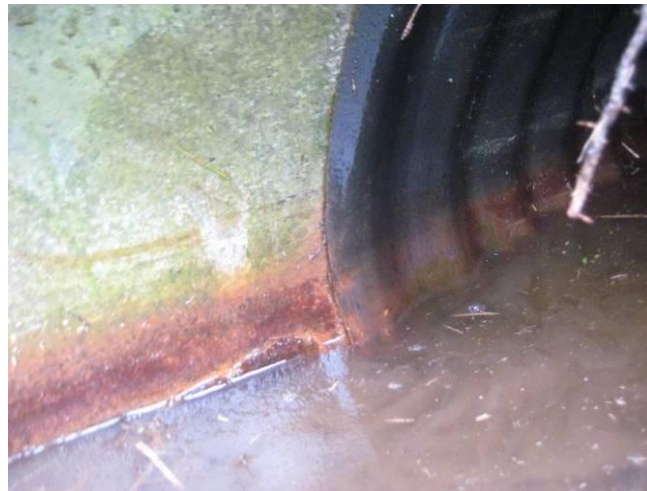
**Location #6** at mile post 17.55 – 28” X 20” Pipe Arch Shape

Pipe Rating – Still Okay 2 (Fair - some wear, but structurally sound). The pipe had standing water on the outlet end. The pipe coating was in good condition. The polymer coating is adding service life to the culvert based on the condition of the galvanized end section.

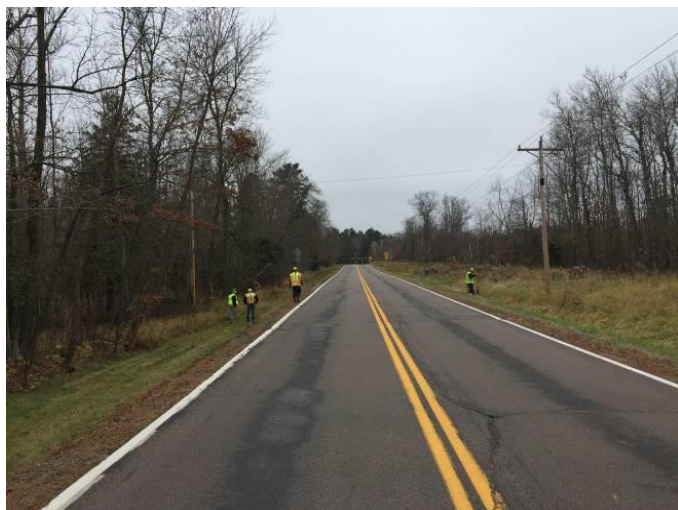
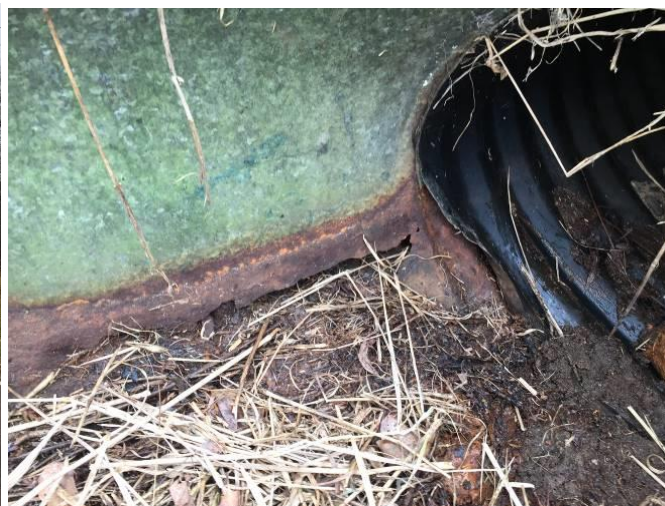
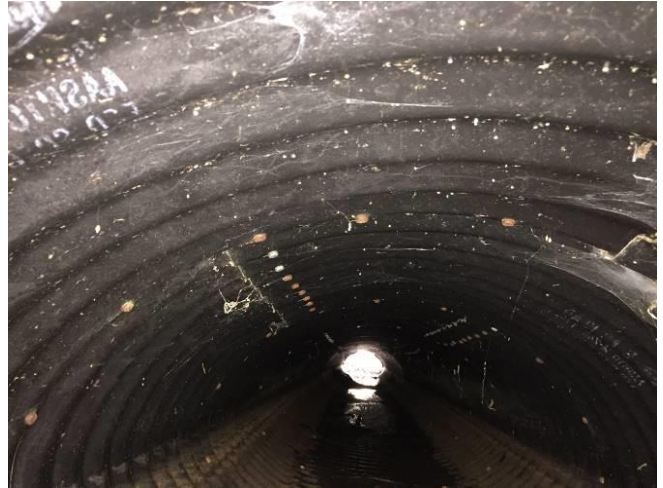
**Location #7** at mile post 18.48 – 28” X 20” Pipe Arch Shape

Pipe Rating – Still Okay 2 (Fair - some wear, but structurally sound). The pipe was in good shape with minor delamination on the inlet end and at a few seams. The galvanized end section was rusty through.

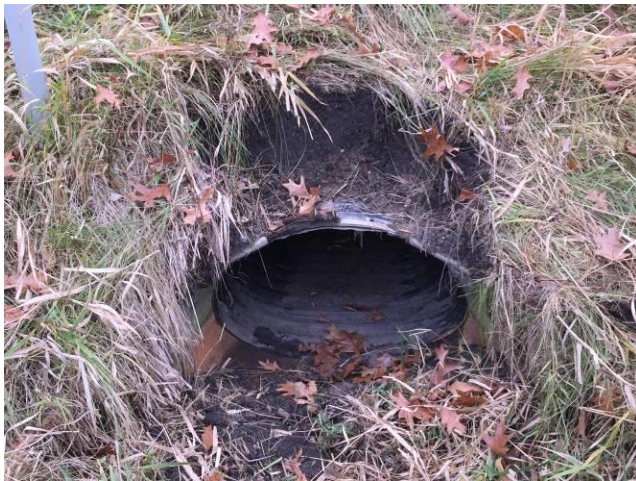
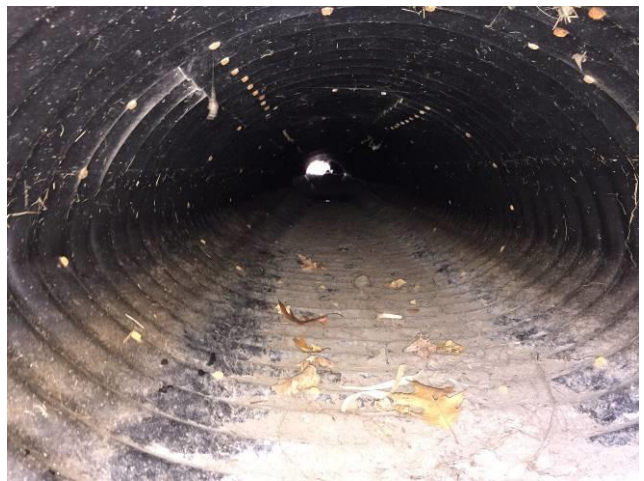
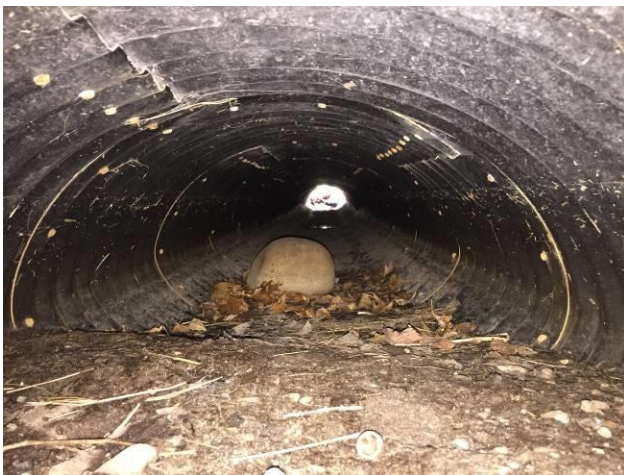
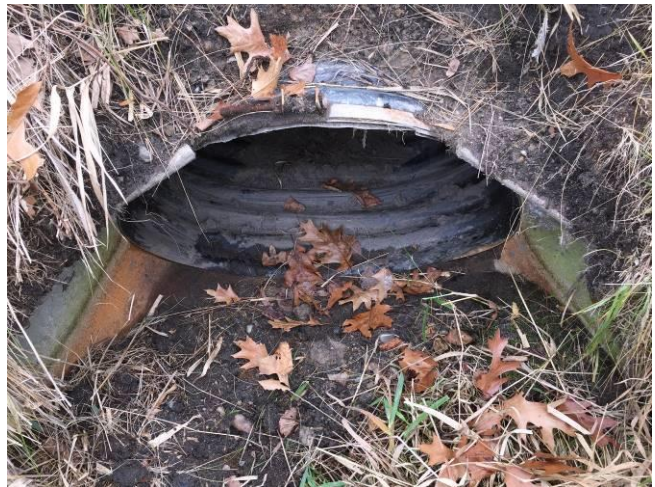
**Location #8** at mile post 18.83 – 28” X 20” Pipe Arch Shape

Pipe Rating – Still Okay 2 (Fair - some wear, but structurally sound). There was sediment in the outlet of the pipe with a boulder resting in the invert. The outlet had sediment which needed to be cleaned for observation of the invert. The polymer coated pipe is in good shape. The galvanized end section is showing corrosion. Most of the culvert was dry at time of inspection.

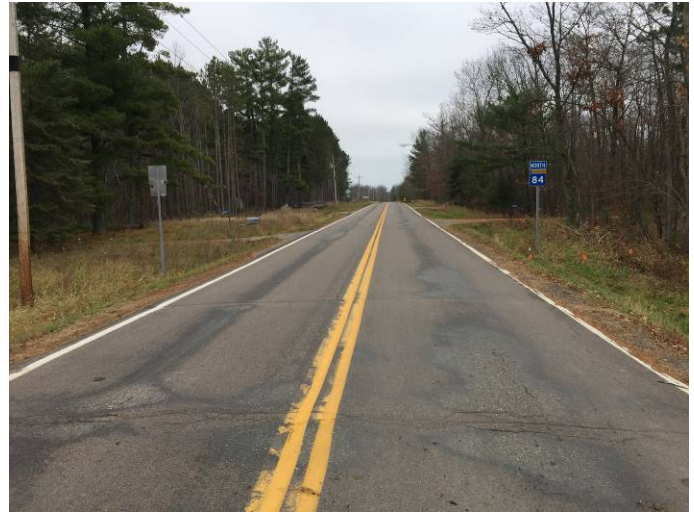
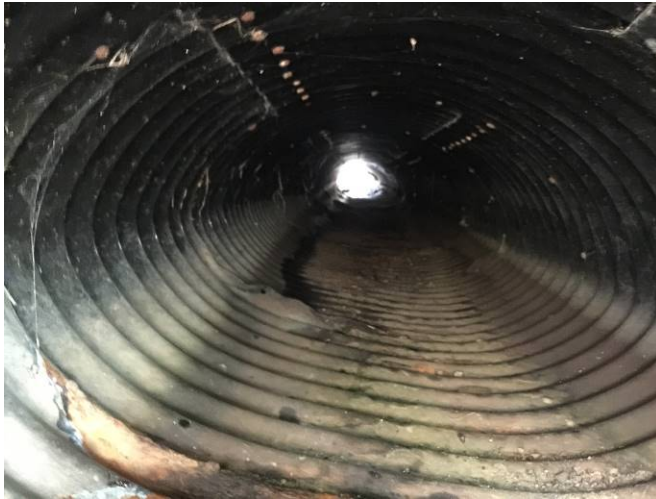
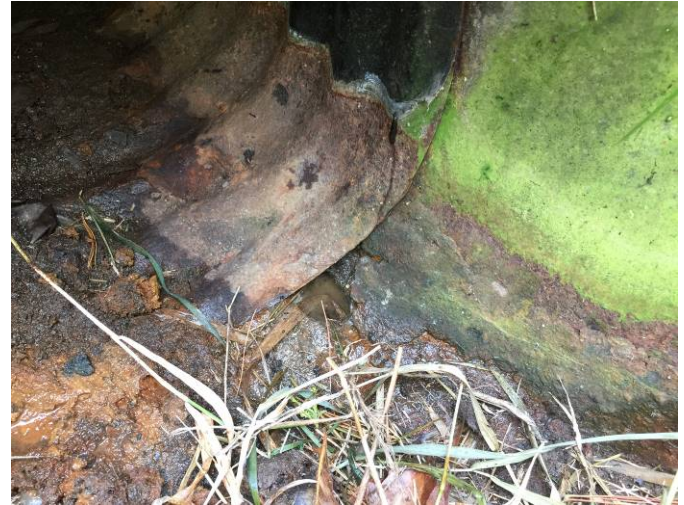
**Location #9** at mile post 19.11 – 28” X 20” Pipe Arch Shape

Pipe Rating – Fix in project 3 (Poor – deteriorated, consider for repair or replacement). The polymer coating on the inlet end did show some delamination. The polymer coating on the remainder of the pipe was in good shape. There was a bump in the road over the culvert. This bump is believed to be from freeze thaw issues which led to the overall pipe rating.

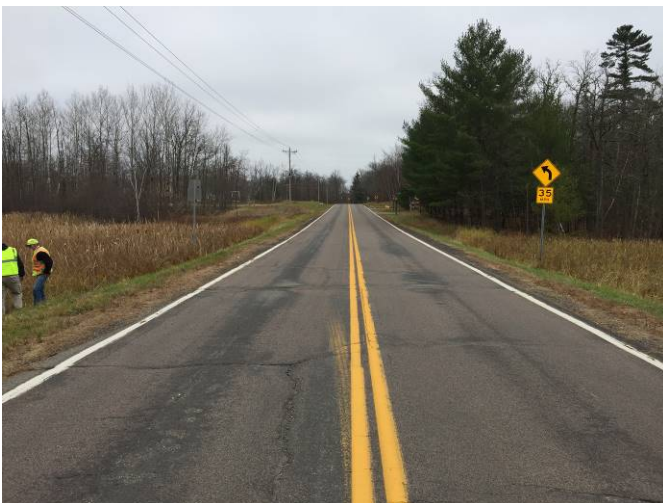
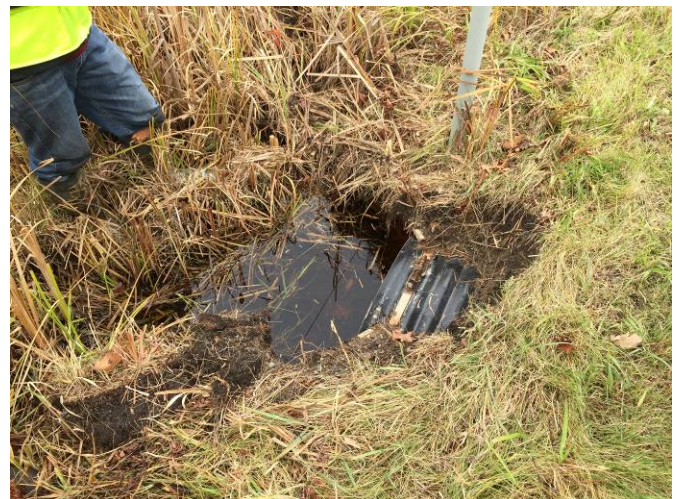
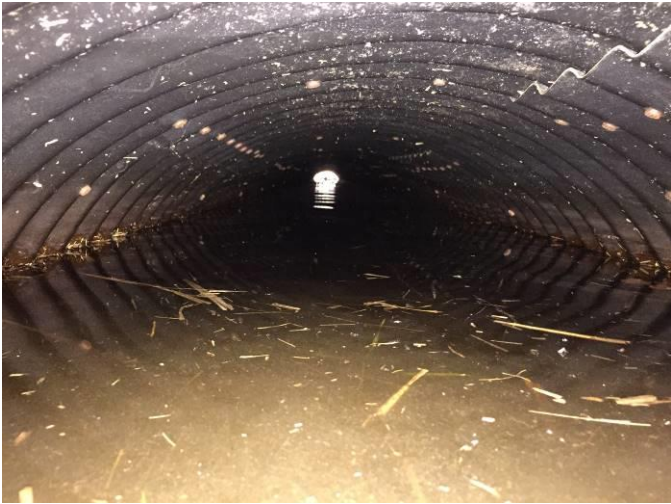
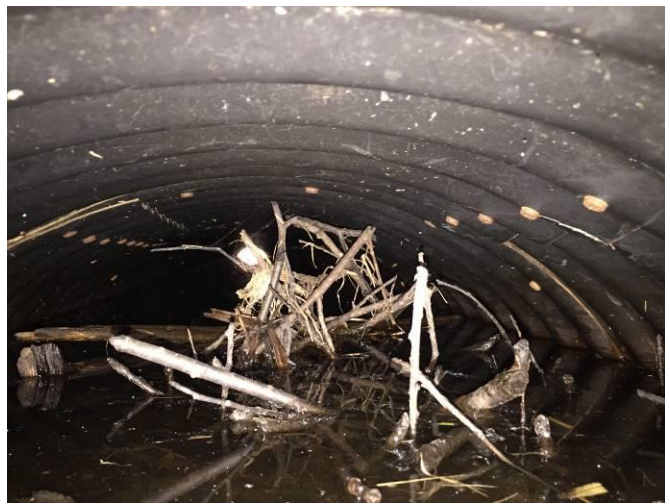
**Location #10** at mile post 19.27 – 28” X 20” Pipe Arch Shape

Pipe Rating – Still Okay 2 (Fair - some wear, but structurally sound). Partially submerged with beaver dam on the outlet end. The polymer coating appeared to be in good shape in the invert when reaching through the water.

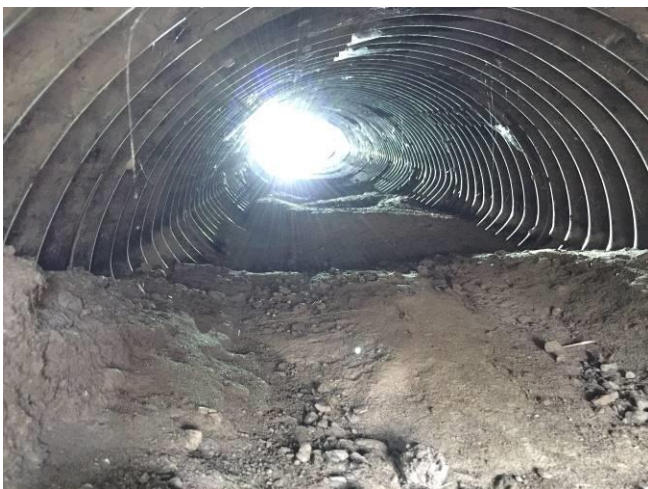
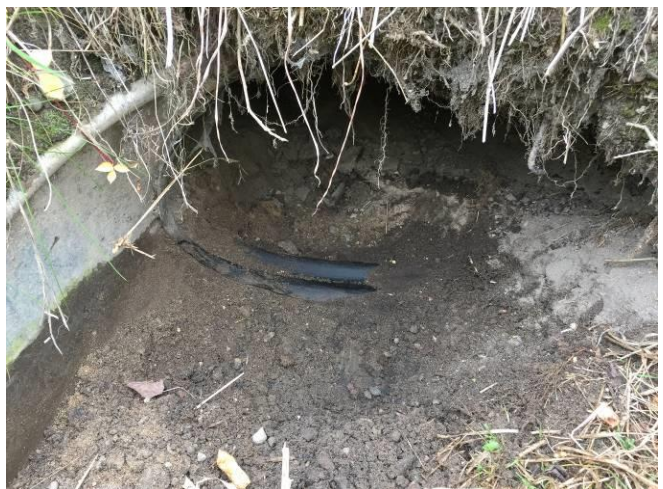
**Location #11** at mile post 21.84 – 28” X 20” Pipe Arch Shape

Pipe Rating – Still Okay 2 (Fair - some wear, but structurally sound). There was sediment in the outlet end. Most of the pipe was free of sediment. The polymer coating was in good shape.

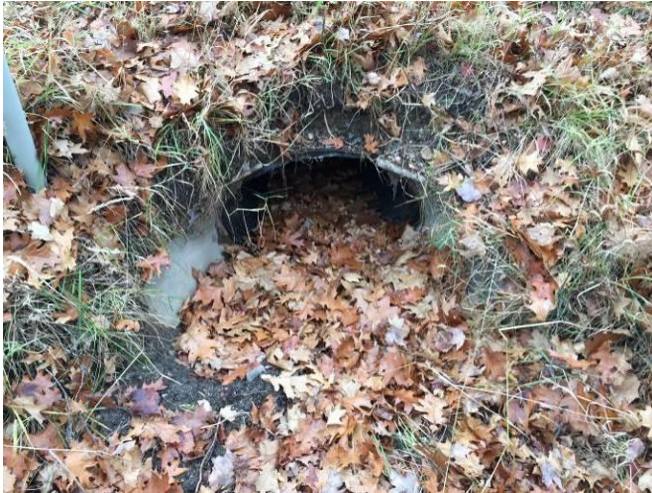
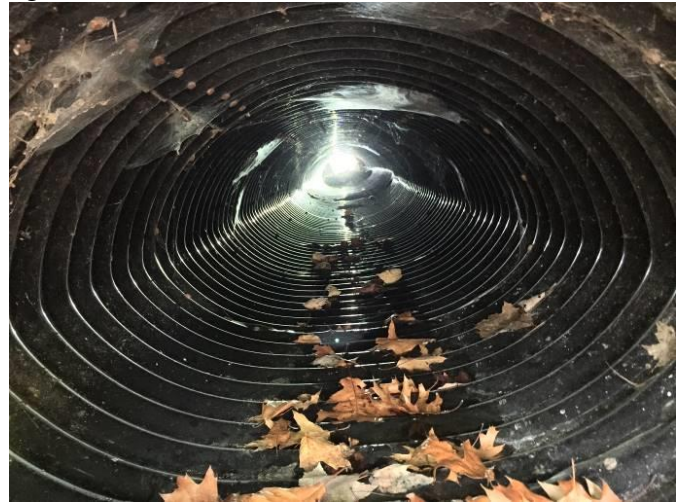
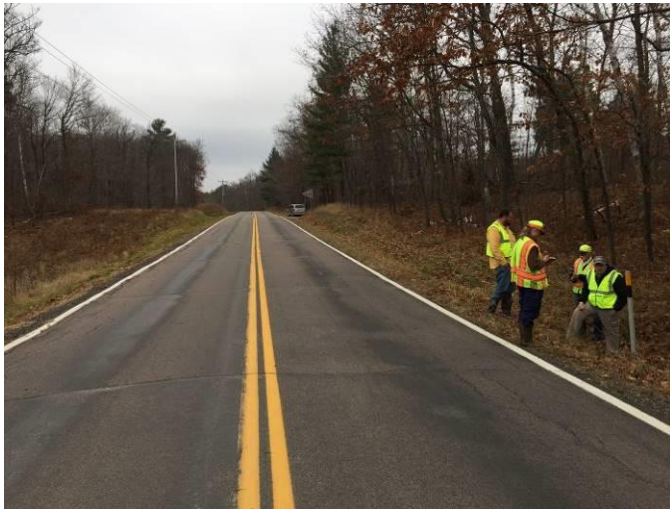
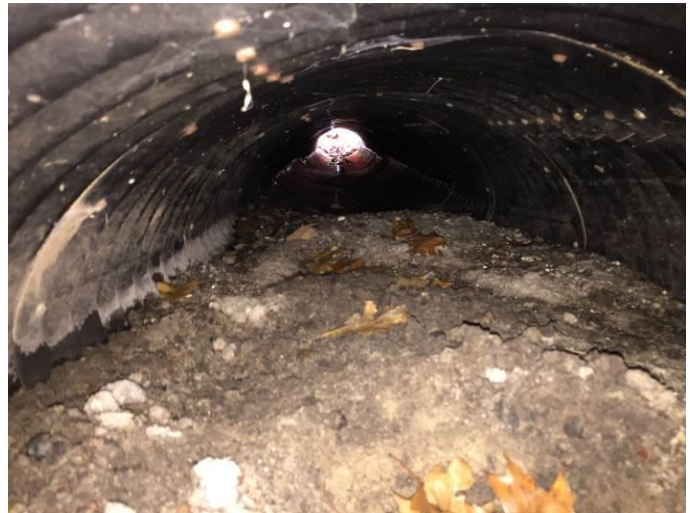
**Location #12** at mile post 23.68 – 28” X 20” Pipe Arch Shape

Pipe Rating – Still Okay 2 (Fair - some wear, but structurally sound). The culvert was mostly dry with sand in the outlet and some leaves on the inlet end. The polymer coating was in good condition.

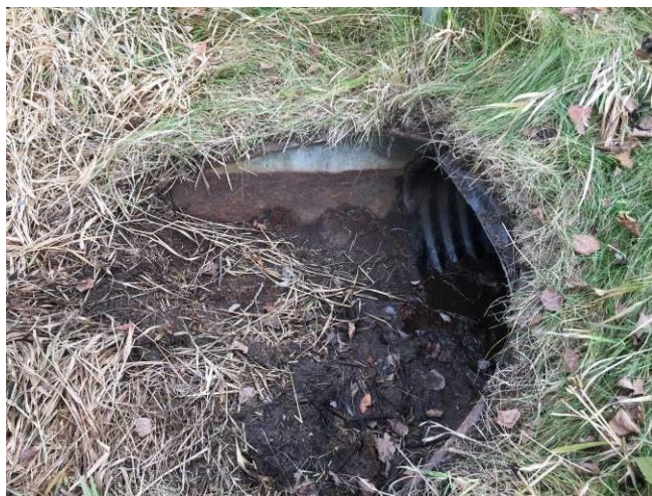
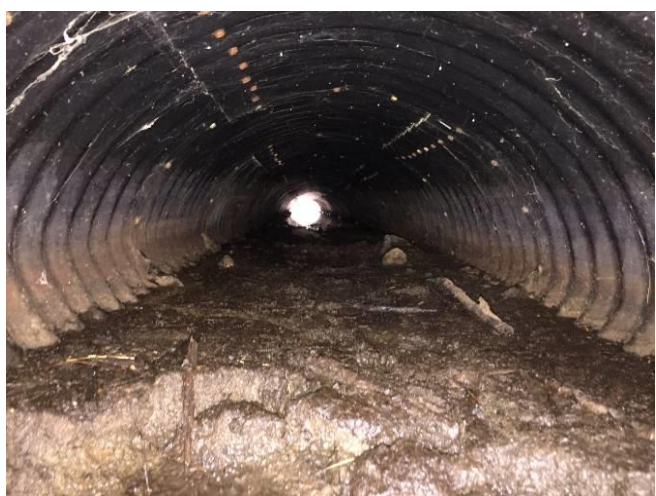
**Location #13** at mile post 29.13 – 28” X 20” Pipe Arch Shape

Pipe Rating – Still Okay 2 (Fair - some wear, but structurally sound). Dry with moist sediment on outlet end. The polymer coating was in good condition. The end section shows corrosion with high water line.
