ALUMINIZED STEEL TYPE 2 SITE VISIT REPORT

DATE OF VISIT: 10/8/2015
 SITE ADDRESS: 850 Spring Forest Dr , LAWRENCEVILLE
 PEOPLE PRESENT: TIM KITTS AND TRAVIS OWEN, SOUTHEAST CULVERT
 ESTIMATE SERVICE YEARS OF PIPE: 28

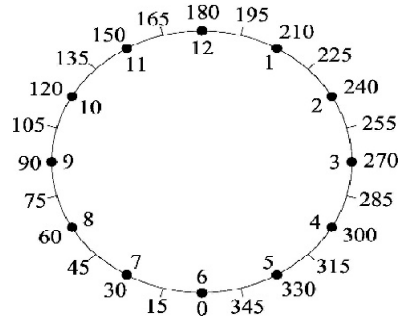
Pipe is on a heavy slope from the street down to a creek. The headwall at the outlet to the creek has come loose from the pipe and has been pushed back several feet. The galvanized stub poured into the headwall is completely gone at the invert. The mainline pipe is rusted at the invert and has several crack size perforations on top of the corrugations at the invert.
