Bernalillo, New Mexico

| DIAMETER | GAGE | YEAR INSTALLED | INSPECTION DATE |
| 30" | 14 (0.079 IN) | ESTIMATED AT 1952 | JUNE, 2012 |

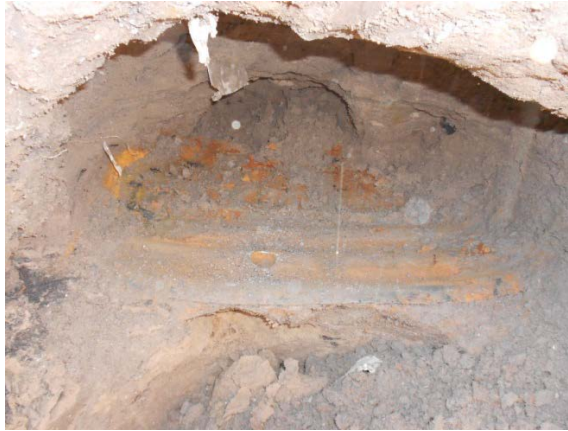
- Pipe appeared to be in fair condition
- Pipe is too full of silt to perform

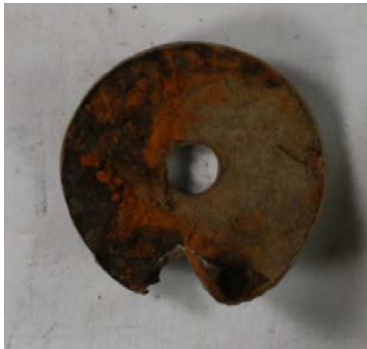
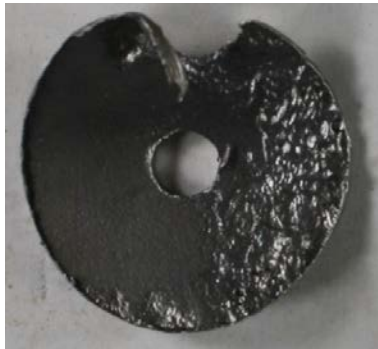
SOIL SIDE ALUMINUM COATING DATA:

- Surface area coated: 0%
- Minimum thickness: 0.00
- Maximum thickness: 0.00
- Maximum pit depth: 57.00 mils

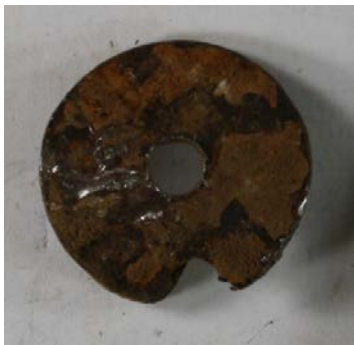
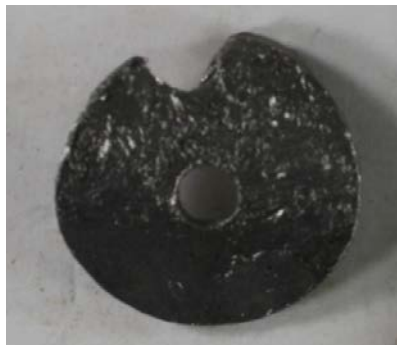
WATER SIDE ALUMINUM COATING DATA:

- Surface area coated: 0%
- Minimum thickness: 0.00
- Maximum thickness: 0.00
- Maximum pit depth: 26.00 mils
