## Fairplay, Colorado

DIAMETER	GAGE	YEAR INSTALLED	INSPECTION DATE
24"	14 (0.079 IN)	ESTIMATED AT 1952	JUNE, 2012
PROFILE	COATING	SOIL DATA	WATER DATA
2 2/3 X 1/2	ALUMINIZED TYPE 2	PH: 6.4	PH: DRY
		RESISTIVITY: 3,218 Ω-CM	RESISTIVITY: DRY
			FHWA ABRASION LEVEL: 3
			CHLORIDES: DRY
			CaCO <sub>3</sub> : DRY

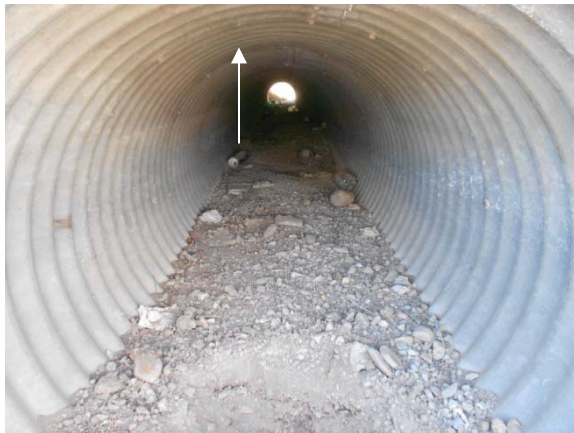
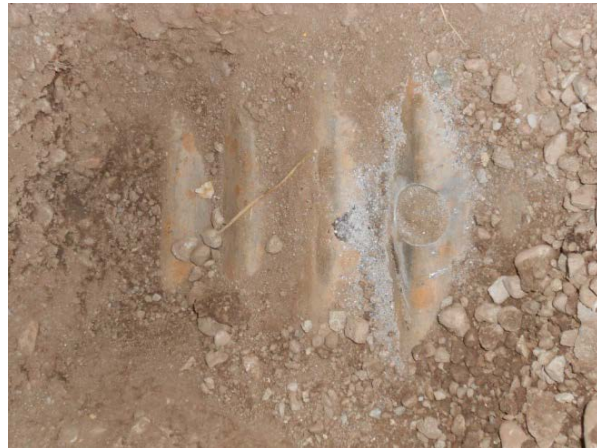
### IMAGES:

- There was no pavement distress
- No further corrosion of trepan holes
- Pipe is in good condition

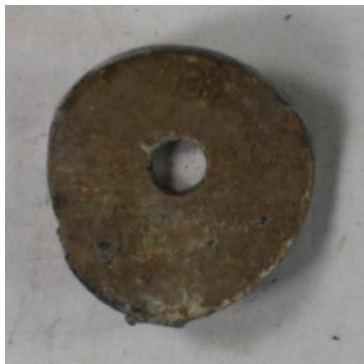
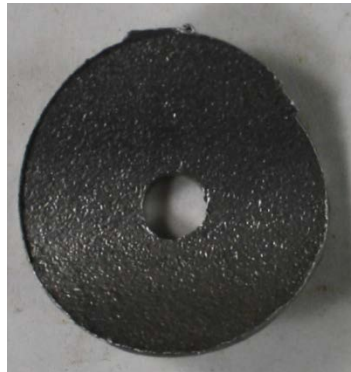
### SOIL SIDE ALUMINUM COATING DATA:

- Surface area coated: 0%
- Minimum thickness: 0.00
- Maximum thickness: 0.00
- Maximum pit depth: 8.50 mils

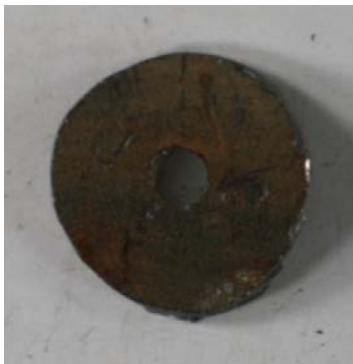
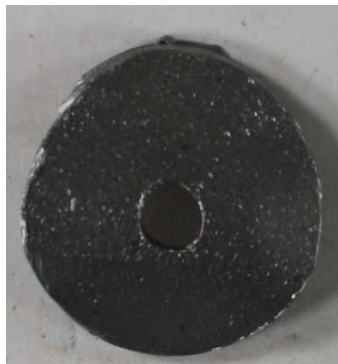
### WATER SIDE ALUMINUM COATING DATA:

- Surface area coated: 0%
- Minimum thickness: 0.00
- Maximum thickness: 0.00
- Maximum pit depth: 5.21 mils
