DURABILITY OF ALUMINIZED TYPE 2 COATED CORRUGATED STEEL PIPE EXPOSED THROUGHOUT THE UNITED STATES

NATIONAL CORRUGATED
STEEL PIPE ASSOCIATION

August 2014

J. PETER AULT, P.E

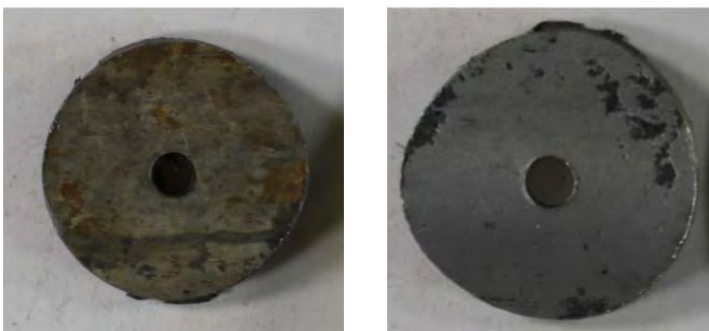
- Surface area coated: 90%
- Minimum thickness: 0.00 mils
- Maximum thickness: 1.78 mils (45 μm)
- Maximum pit depth: 1.23 mils

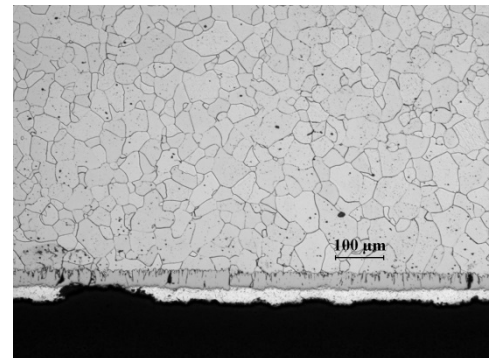
- Surface area coated: 5%
- Minimum thickness: 0.00 mils
- Maximum thickness: 0.00 mils
- Maximum pit depth: 0.73 mils

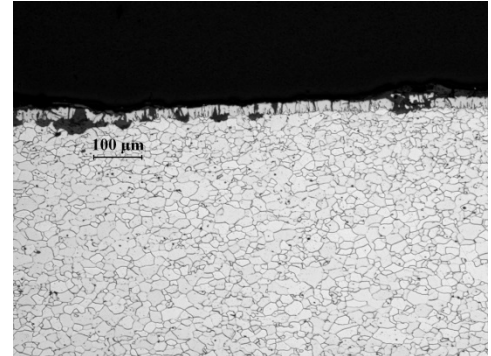
- Surface area coated: 5%
- Minimum thickness: 0.00 mils
- Maximum thickness: 0.00 mils
- Maximum pit depth: 12.00 mils

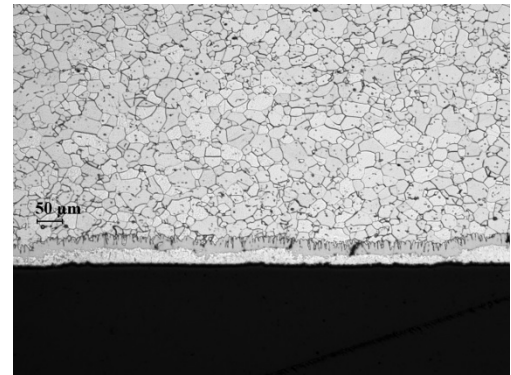
- Surface area coated: 100%
- Minimum thickness: 0.00 mils
- Maximum thickness: 1.87 mils (47.5 μ m)
- Maximum pit depth: 1.60 mils

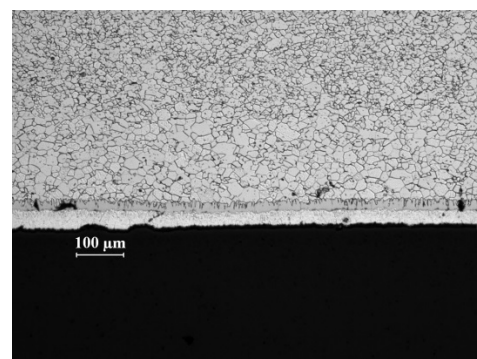
- Surface area coated: 100%
- Minimum thickness: 0.55 mils
- Maximum thickness: 2.28 mils (58 μm)
- Maximum pit depth: 1.35 mils

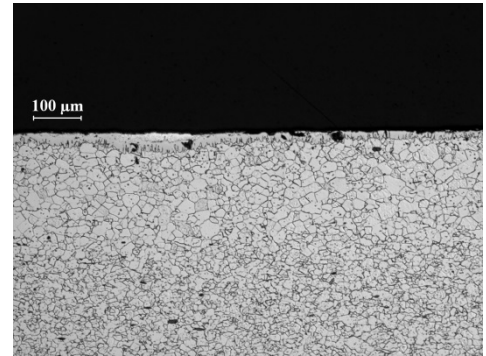
- Surface area coated: 65%
- Minimum thickness: 0.00 mils
- Maximum thickness: 1.72 mils (43.5 μ m)
- Maximum pit depth: 4.97 mils
