Dulles Rt. 28, Pacific & Commercial crossing 2
4-180' x 60" RCP

Introduction

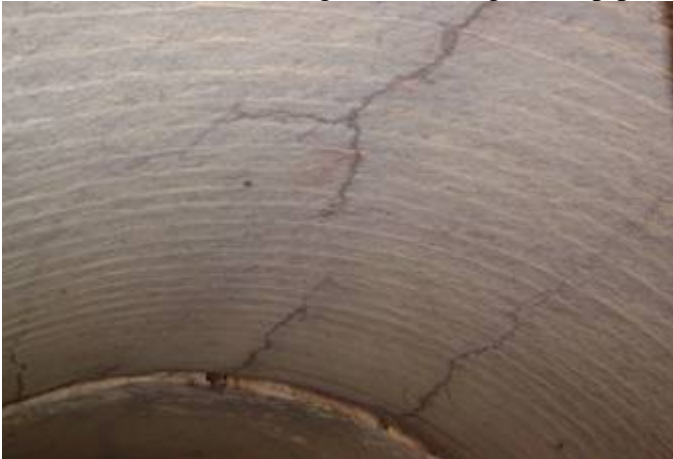
1-crown cracks indicating over loading of the pipe

The crown cracks are of concern for possible future structural degradation. Imminent structural failure is not a concern. The crown cracking occurred in two locations in adjacent sections of pipe at each location. Each pipe section is 7 feet 6 inches in length, making the area of concern 15 feet long. The first location is pipe sections 23 and 24 in pipe line 2. These are the first 2 pipe on the west end of the pipe line 2. The second location is pipe sections 2 and 3 in pipe line 3. These are 1 pipe from the east end of pipe line 3. This will allow easy access for a structural repair of these sections.

The pipe sections with crown cracking can be repaired by use of structural lining.

The repair in Pipeline 2 would be 15 feet long and would be transitioned on the upstream flow end to provide a smooth flow. The repair in Pipeline 3 should be 22.5 feet long extending from the East opening to the 3rd joint. No transition is required since it is the beginning end of the culvert pipe. A Cured- In- Place Pipe (CIPP) liner would be easily installed and has been used in other locations of VDOT jurisdiction. It is one of the approved methods on list 38 –“Pipe Rehabilitation Methods”. The list is attached for your reference as Appendix B.

Contact was made with Insituform Technologies in Odenton, Maryland to gather planning costs for the lining of the two areas of crown cracked pipe which indicate overstressing of the pipe and require structural lining. Each area can be lined with CIPP lining for \$35,000 each. The total would be \$70,000 for the structural lining repairs. This covers material, labor and mobilization costs. If the project moves ahead, they will

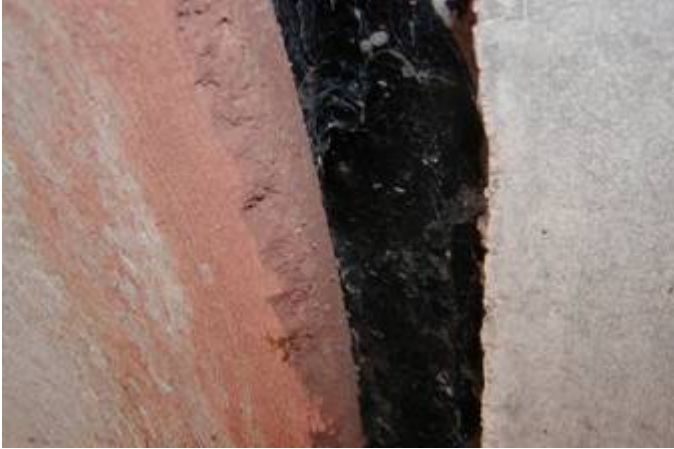
2-joints which are open more than tolerance allowance

The joint openings are of concern because of the potential for water to enter the pipe and cause a loss of soil on the outside of the pipes. Over time this could result in subsidence of the area above the pipes.

The joint areas that are open to a position of questionable tolerance can be corrected by grouting through the joint into the area outside of each joint. A grout which mixes with the soil to form a barrier which does not allow water to flow into the joint will be used. This will preclude any flow through the joint and not allow any loss of soil from outside the pipe. There will be no risk of subsidence above the joint areas from loss of soil around the joint. The installation will take place from inside the pipe and no disturbance will be required on the surface. This repair will result in the service life of the joints being restored to original new installation levels. Contact with VDOT has been made and the list of approved non-shrink grouts is to be provided.

Contact was made with National Gunitite who is presently doing work for VDOT and they gave a planning cost of \$2500 a joint to use non-shrink grout to provide soil stabilization around the joints to preclude any water flow or soil loss into the pipe. There are 5 joints for a total of \$12,500 for the joint grout work. The contractor will review in more detail when authorized and the cost may come down slightly.

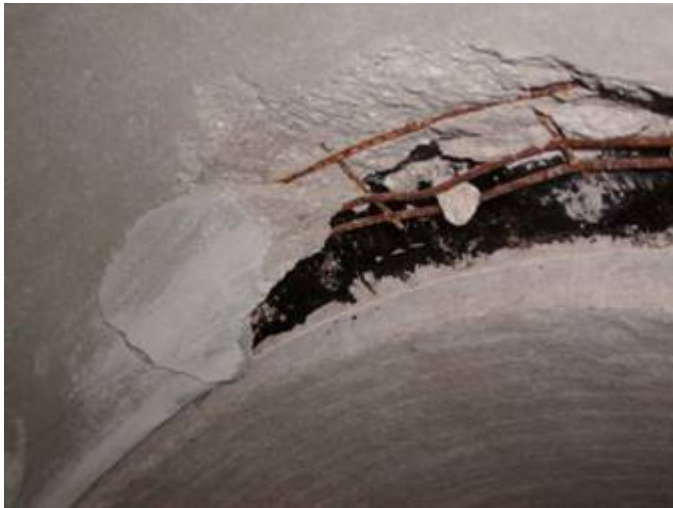
3-broken joint areas

The broken joint areas need to be repaired to protect the integrity of the pipe, reinforcement and joint. This will result in the joints and pipe meeting their intended service life.

The areas of broken joints can be repaired using VDOT approved hydraulic cement patching material to provide a smooth wall surface and to protect the reinforcing in the pipe. These compounds adhere to the cleaned area and will meet the useful life assigned to a new pipe surface. The VDOT list number 31 gives the approved patching materials for use on VDOT projects and is attached as Appendix C.

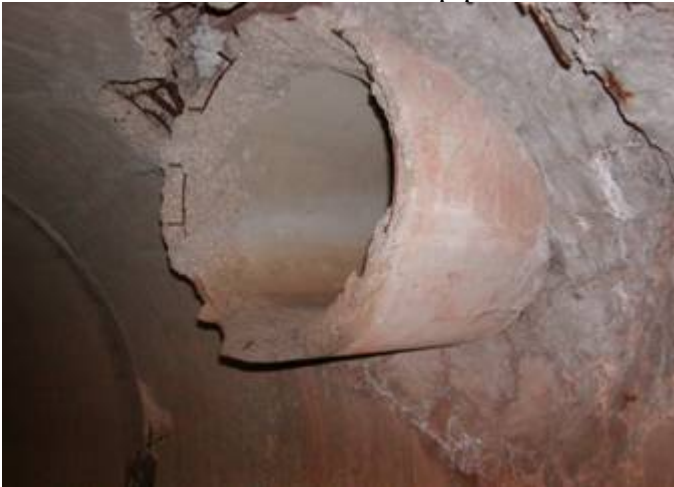
4-connections to the main culvert pipes are not finished properly

The unfinished area around the connections and the protruding connections can affect the flow characteristics designed for the pipes. There was exposed rebar in the area of each of the connection areas which can deteriorate from improper protection. The protruding connections can catch debris in large flow situations and result in restricted flow or possible blockage of flow.

The connection area problems can be corrected by cutting off protruding pipes and finishing the wall area as a new installation would be installed. Approved compounds found on list 31 will be used to fill and finish the area of the connections. This will give the service life of a newly installed connection area. No flow problems or debris collection will occur after these connections are finished off properly.
