# **A STUDY IN SERVICE LIFE**

**El Dorado County, CA**

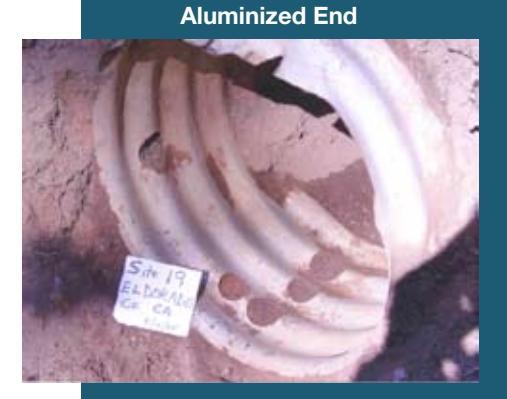
18" diameter ALT2 on the inlet end; galvanized outlet was not accessible. Currently dry - no recent rainfall. Pipe is silted to approximately half full. It has a low overburden and some ovality is evident in the middle of the road. Aluminized pipe end is only 2' from the edge of the pavement; not much vegetation nearby. ALT2 is in very good condition; previous hole saw cuts are intact with no appreciable "creep".

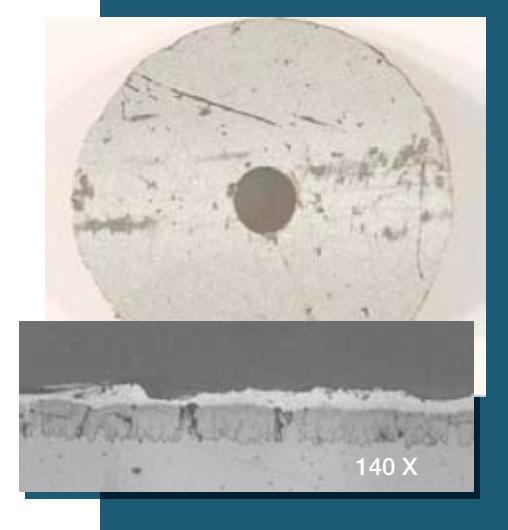
ALT2 Water Side

Coupons were bead blasted to remove loose oxides and images were recorded of the remaining surface (see images on right). Water side is smooth; there is some minimal pitting present on the soil side. The iron-aluminum alloy layer still remains on most of the soil side.

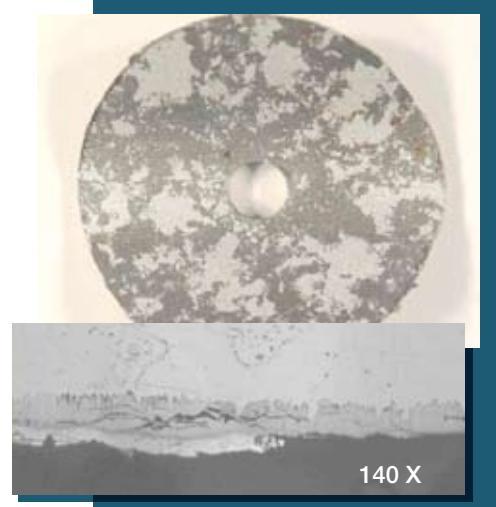
#### ALT2 Soil Side

**Micrometer Results – Ball:** 0.068", 0.068", 0.067" **Point:** 0.061" (0.007" deep)
