**POLYMER COATED
STRUCTURAL PLATE
AND FASTENER
TESTING
FINAL REPORT**

Polymer Coated Structural Plate and Fastener Testing

Final Report

National Corrugated Steel Pipe Association

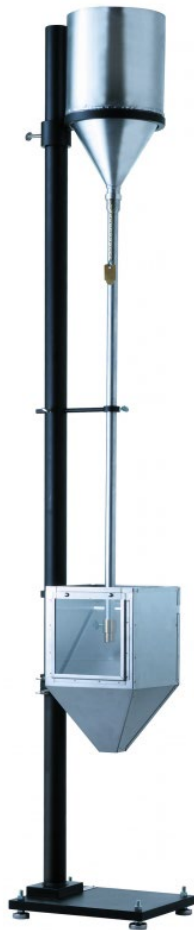
Figure 2: ASTM D986 Testing Apparatus

The abrasion testing performed in this study followed a modified version of ASTM D968, *Standard Test Methods for Abrasion Resistance of Organic Coatings by Falling Abrasive*. The method involves incrementally dropping a measured volume of abrasive media from a specified height through a guide tube onto a coated surface until the coating erodes away to reveal the underlying substrate (Figure 2). Preliminary trials showed the plate coatings used in this study were highly resistant to the silica sand that is typically used in this test. As such, the standard silica sand abrasive was replaced with 25-40 mesh steel grit, which is approximately 30% harder than silica sand. The values presented in this report are shown in liters/mil representing the volume of abrasive media it takes to erode one mil of coating.

Testing was repeated using the end criteria in ASTM D986. Prior to testing, the coating thickness is measured in the test area. The steel grit was poured in 2-liter increments into a funnel with a 0.75-inch inner diameter down a guide tube 3-feet long at a stand-off distance of 1-inch from the panel. Panels were visually inspected for coating erosion after each pour. Testing was considered complete after a 4-mm spot had worn through the topcoat and the underlying zinc coating was visible. Coating thickness measurements were taken after 10, 20, 50, and 100L of abrasive. The data was curve fitted to determine an erosion rate.

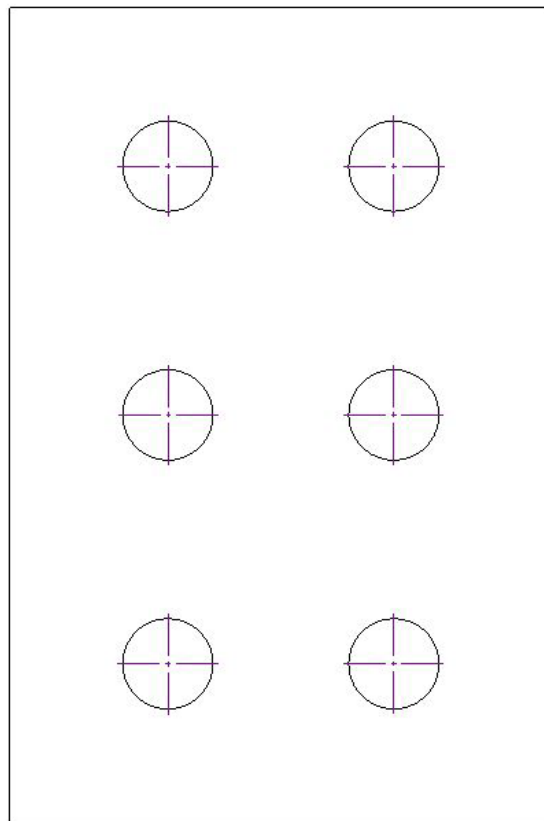
Figure 5: Fastener Coatings Test Plate Drawing

The fastener coatings were evaluated by installation into 6-inch by 9-inch steel panels with evenly spaced 1-inch diameter holes as shown in Figure 5.

Plate coatings were originally evaluated on two different panel geometries, with a total of ten panels being tested for each coating system. Six of the panels were sized 4-inch by 6-inch 10-gage steel panels and were used to test the plate coating by itself. The remaining four were 6-inch by 9-inch 10-gage steel panels. The larger panels were used to test the coating as well as six fastener coatings. These panels incorporated 6 evenly spaced 1" holes as shown in Figure 5.

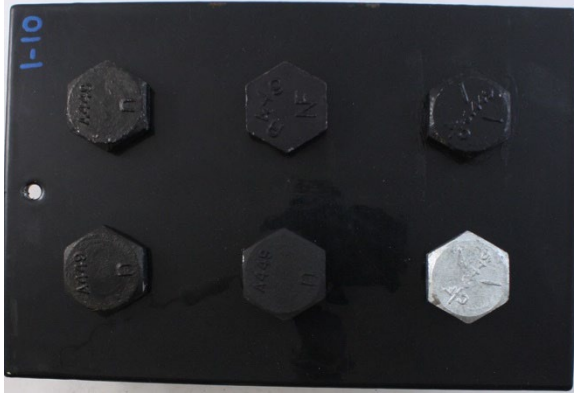
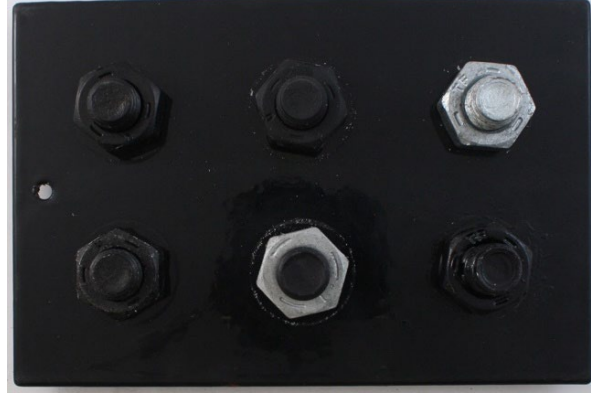
Figure 6: Representative Fully Assembled Test Panel

Each fastener was installed using a pneumatic impact driver (three seconds at 60 psi on the tool's medium setting) then tightened further to 150 ft-lbs using a torque wrench. This created small defects in both the panel and bolt coatings from the impact socket representative of those created in the field when installed, while also ensuring equal amounts of force at the bolt head/panel/nut interfaces for all panel and fastener coating combinations. Figure 6 shows an example of a fully assembled panel prior to testing.

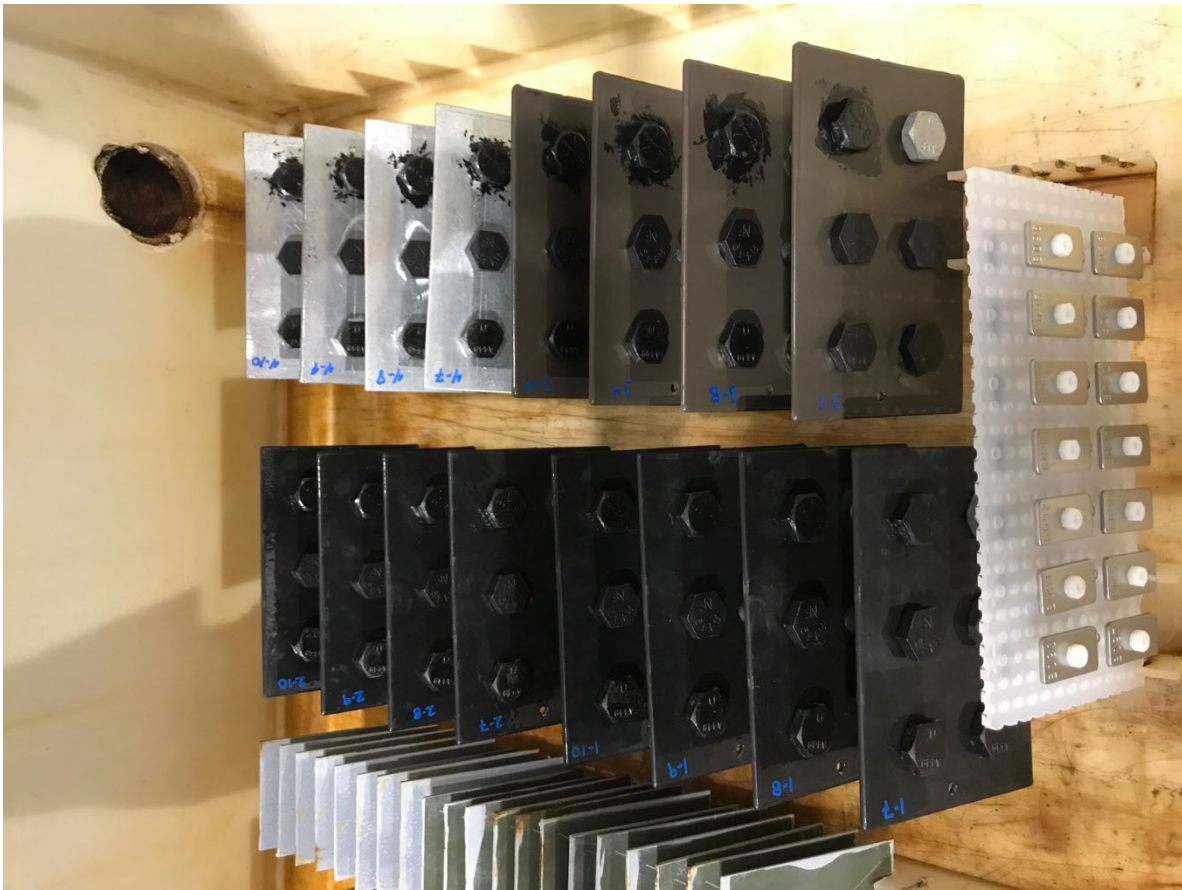
Figure 7: Test Panel Array in GM Test Chamber

Test panels were installed at $20^\circ \pm 5^\circ$ from vertical in a non-metallic rack prior to the start of testing with the bolt head side facing in the direction of the salt solution spray. Figure 7 shows the test panels arranged in the GM cabinet prior to any salt solution spray. Halfway through the testing (after 30 cycles), the panels were rotated so that the nut and bolt threads faced in the direction of the salt solution spray.

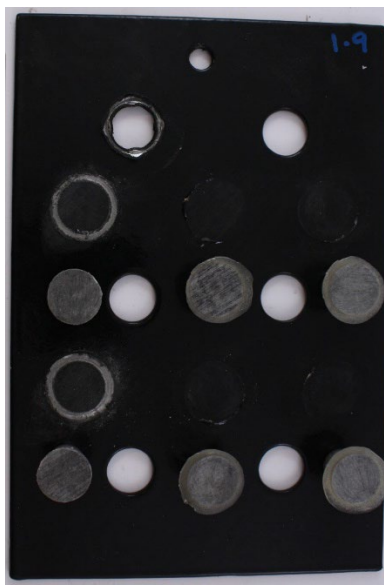
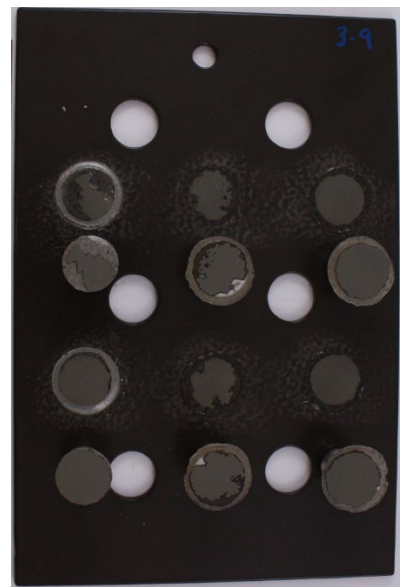
Figure 8: Samples Post Adhesion Testing for Plate Coatings

Table 4 summarizes pull off adhesion test data. All failures in Polyarmor G17 systems and Trenchcoat occurred adhesively at the glue/topcoat interface. These results indicate that the true adhesion of the coating to the substrate exceeds the measured value. Failures in the polyester coating occurred cohesively within both the topcoat and the primer, and adhesively at the glue/topcoat interface. Figure 9 shows adhesion panels and their corresponding adhesion dollies after testing. While there are no standards for Adhesion values more than 1,000 psi are generally considered good for industrial coatings. The data suggests an acceptable level of tensile adhesion performance and suggests similar service performance related to tensile adhesion stresses.

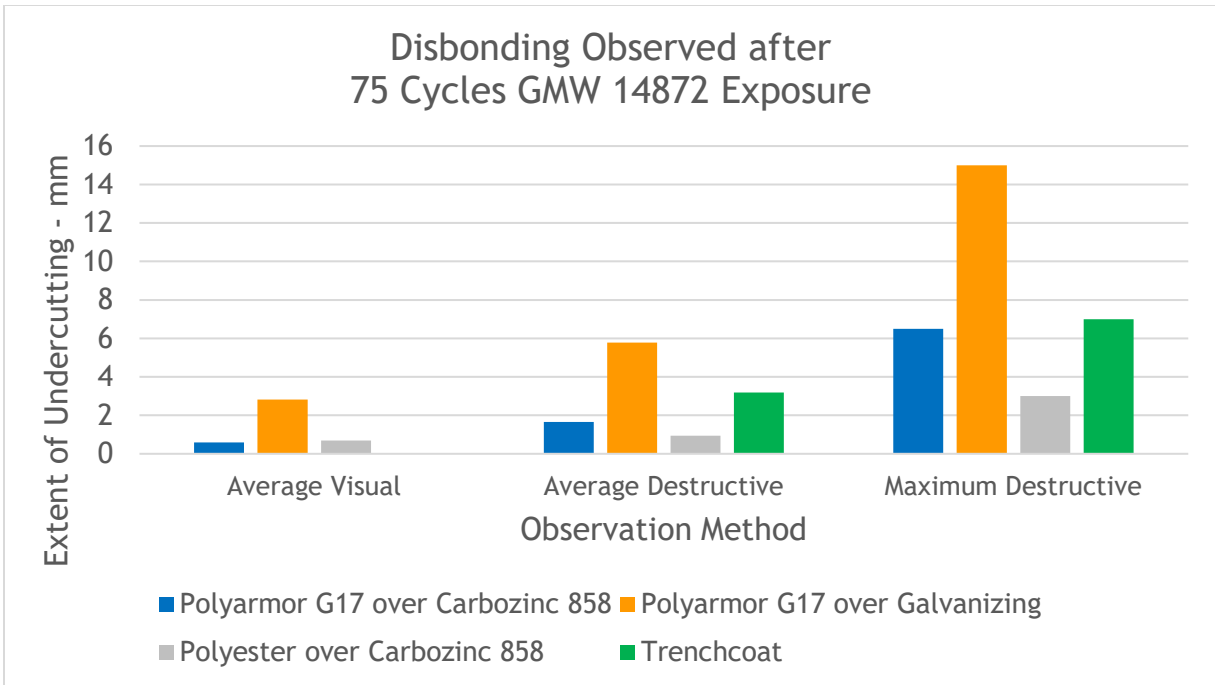
Figure 18: Observed Disbonding After 75 Cycles GMW 14872

The extent of undercutting that can be visually observed is not always the full extent of disbanded coating. To fully characterize the coating performance, the extent of disbonding was destructively evaluated at the end of 75 exposure cycles by removing the coating using a razor knife. Figure 19 summarizes these measurements.

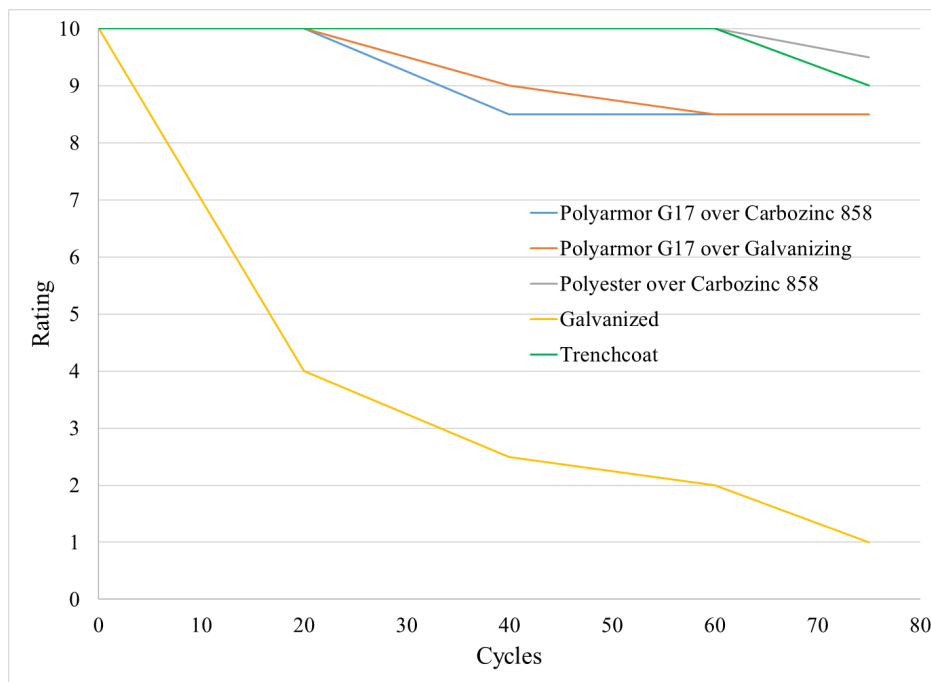
Figure 19: Average D610 Rating Over Time

The extent of rust-through observed for each coating was recorded at each inspection. Figure 20 shows the ASTM D610 ratings for rust-through made throughout testing. This parameter demonstrates the failure mode of the galvanized coating. After 75 cycles of exposure, the galvanized panels had an average rating of 2 which corresponds to 33.0% rust through. All polymer coatings had average rust ratings above 8, which is less than 0.1% rust-through.

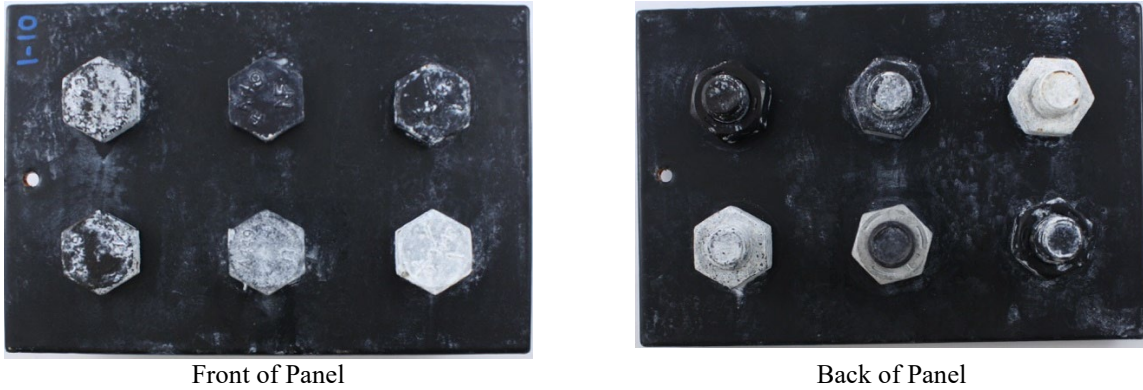
Figure 20: Example Panel After 60 Cycles

Each fastener was visually inspected for the presence of steel corrosion through the coating using the ASTM D610 scale in the three locations described above. Figure 21 shows the same panel as Figure 6 after 60 cycles.
