DURABILITY OF ALUMINIZED TYPE 2 COATED CORRUGATED STEEL PIPE EXPOSED THROUGHOUT THE UNITED STATES

NATIONAL CORRUGATED
STEEL PIPE ASSOCIATION

August 2014

J. PETER AULT, P.E

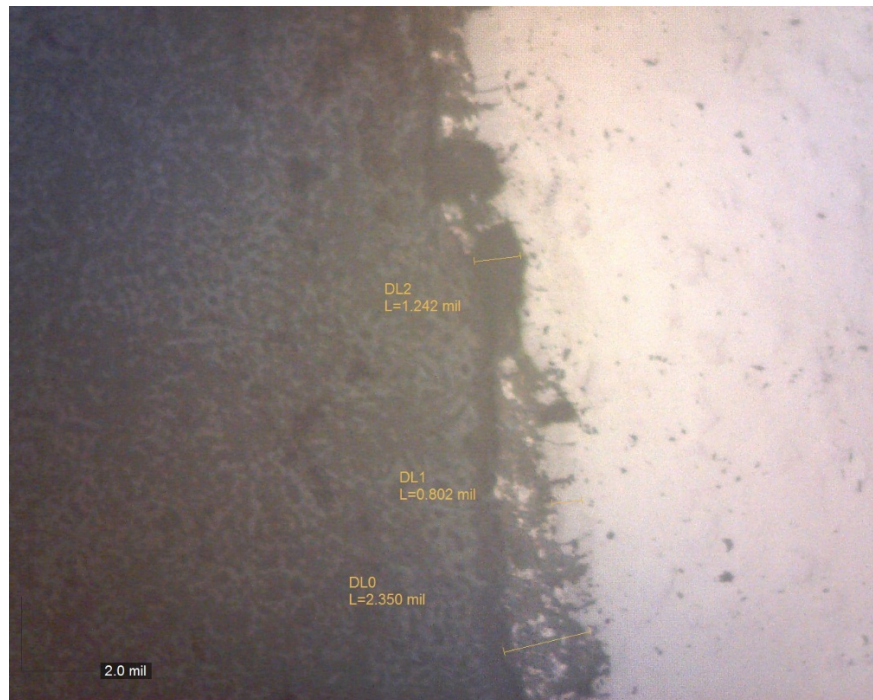
Figure 2. Representative Micrograph

Precision cuts were made through an area of interest on each sample. This was often through the most severe pitting found on the sample, but this single pit may not be representative of the pitting severity along the whole sample or the whole pipe. These pieces were mounted in epoxy and finished with a progressively finer abrasive. Finally, a Nital etchant was used to expose the aluminum-iron alloy formed during the pipe sheet production process. Once sample preparation was complete the samples were able to be observed under a microscope. Digital images were analyzed to determine the thickness of the Aluminized coating, alloy layer (when aluminum was removed) and depth of any pits observable within the sample. Figure 2 shows representative measurements.

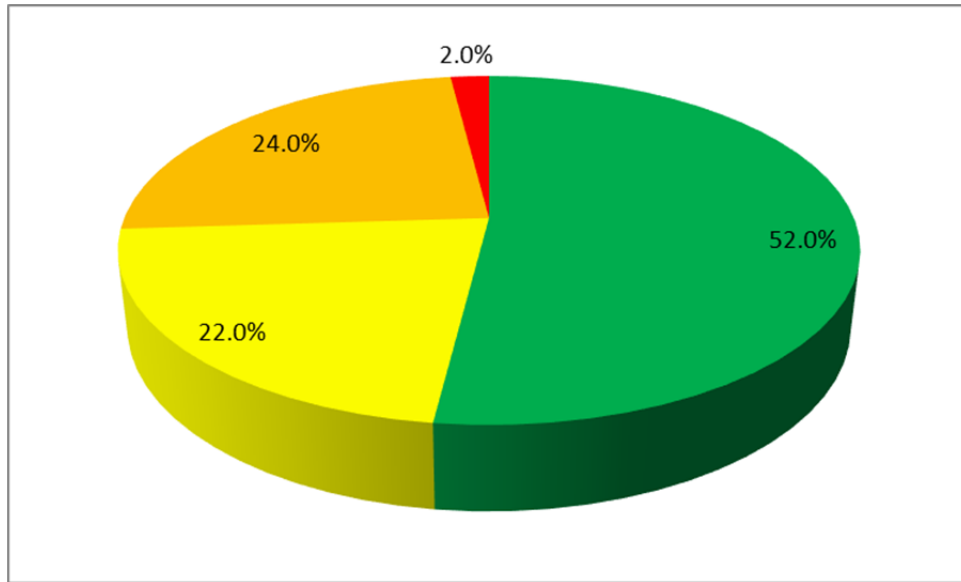
Figure 3. Distribution of Conditions

In an attempt to get a broader perspective of the performance of Aluminized coated CSP over time, all available data from AK Steel’s reports (30, 43 and 50 year), FHWA-FLP-91-006 and FHWA-RD-97-140 and the current inspections was compiled. Each pipe was categorized into one of four categories based on the depth of pitting and extent of coating loss. Table 3 shows the rating scheme. In all, over 170 individual inspections were recorded and categorized. Figure 3 presents the total number of observations in each category. Note that the perforated pipes are those which have previously been identified as experiencing abrasion beyond the recommended level.

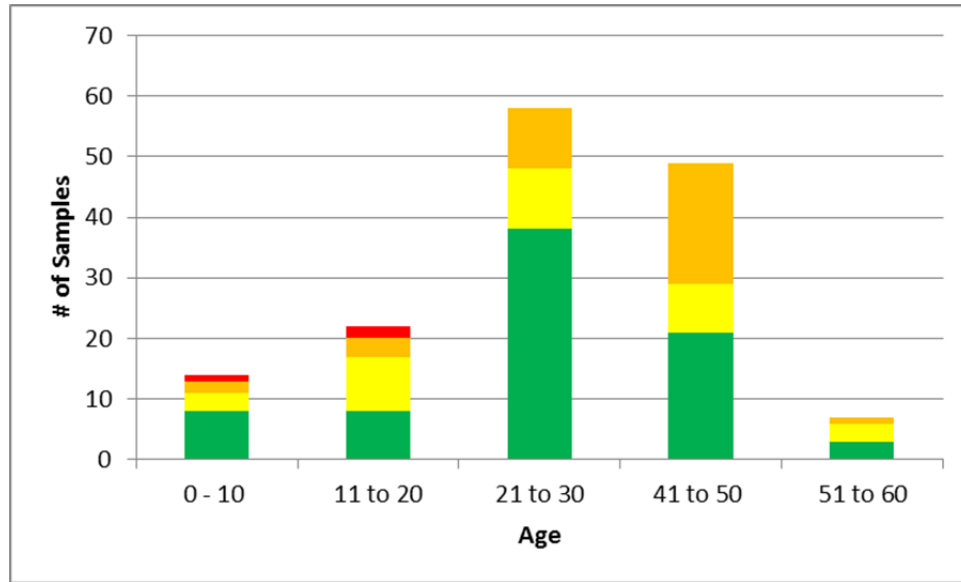
Figure 4. Samples Categorized by Grade and Age

Figure 4 shows the same data as Figure 3 except it is separated by pipe age at the time of the inspections. The most data was collected when the pipes had between 21 and 30 years of service. At that period the number of pipes in the green category is very high. This shows that through 30 year of service almost no pitting is present (38 pipes). There are ten samples in each of the yellow and orange categories. Although these pipes are beginning to show signs of wear they still hold most of their steel substrate and, for those in yellow, often some of the Aluminized coating. As the pipes age a shift in the data can be seen. Note that no inspections were conducted of pipe with 31 to 40 years of service. At the 41 to 50 years of service sample categories begin to shift toward the yellow and orange. This means that around 50 years of service the Aluminized coating becomes penetrated at a higher rate. Following this phase of the coating breakdown the base metal steel will then begin to corrode. A limited number of sites were inspected at 60 years of service. Of the sites inspected, all remained in the same categories from their 50 year inspection.

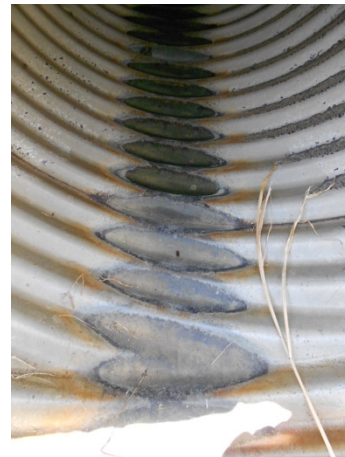
Figure 10. Coating removed due to bed load

One additional important parameter in the study of CSP is the bedload experienced. The effect of bedload on Aluminized pipe is obvious from the wear patterns in the aluminum oxide layer. As would be expected, bedload only wears the Aluminized coating from the upstream side of the corrugation. Figure 9 and Figure 10 show examples with wear on one side of the corrugation. The lower portion of the sample is a darker color, because bare steel is exposed due to abrasion. Analysis of the pits on each sample reveals two unique characteristics of pitting. In samples where abrasion is a clear concern we see a large density of pits on the upstream half of the sample (see Figure 9). These pits typically have a wide mouth in comparison to their depth, and are also deeper than most general corrosion pits. Pitting

which is associated with general corrosion typically has a low pit density, is scattered throughout the entire surface area of the sample and has shallower depth than pits in areas subject to abrasion. Typically, these pits are also much narrower than those found in abrasion areas. If abrasion levels beyond those recommended are present, a decrease in service life is to be expected.

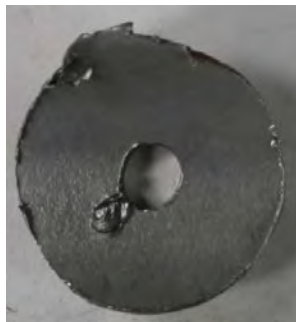
SOIL SIDE ALUMINUM COATING DATA:

- Surface area coated: 100%
- Minimum thickness: 0.73 mils
- Maximum thickness: 1.63 mils (41.5 μm)
- Maximum pit depth: 1.31 mils

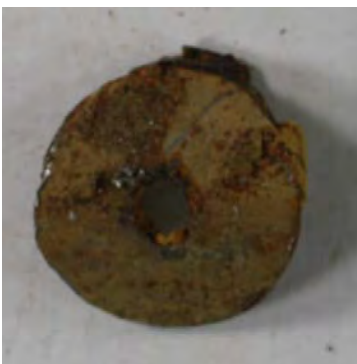
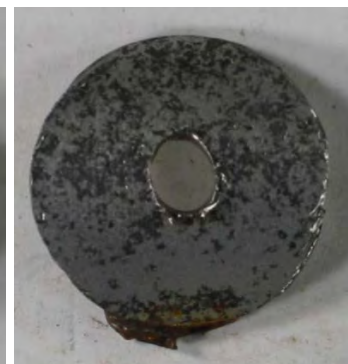
WATER SIDE ALUMINUM COATING DATA:

- Surface area coated: 80%
- Minimum thickness: 0.00 mils
- Maximum thickness: 1.25 mils (32 μm)
- Maximum pit depth: 2.73 mils

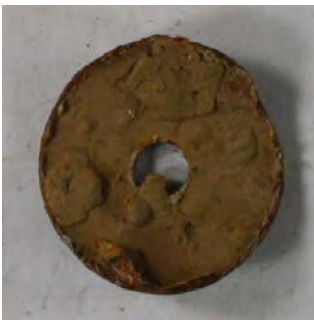
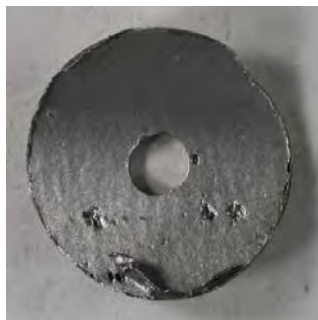
SOIL SIDE ALUMINUM COATING DATA:

- Surface area coated: 100%
- Minimum thickness: 0.84 mils
- Maximum thickness: 2.55 mils (65 µm)
- Maximum pit depth: 16.00 mils

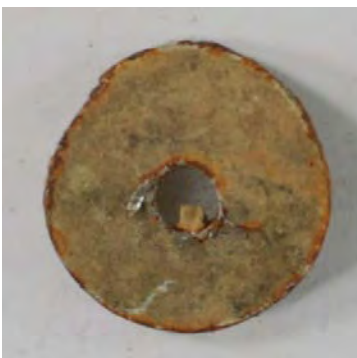
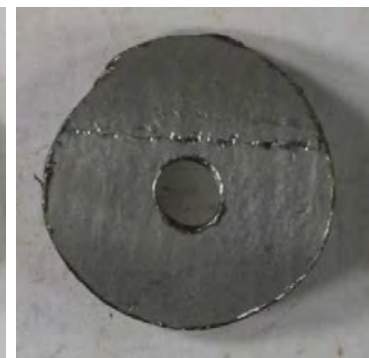
WATER SIDE ALUMINUM COATING DATA:

- Surface area coated: 100%
- Minimum thickness: 0.00 mils
- Maximum thickness: 2.03 mils (51 µm)
- Maximum pit depth: 1.38 mils

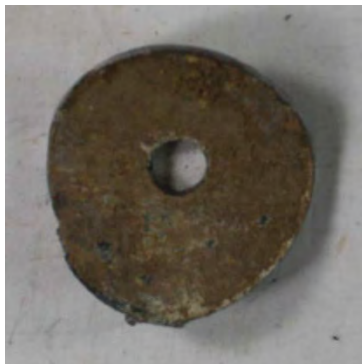
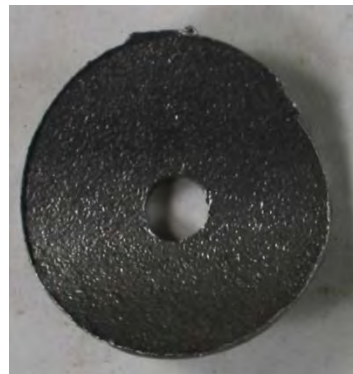
SOIL SIDE ALUMINUM COATING DATA:

- Surface area coated: 0%
- Minimum thickness: 0.00
- Maximum thickness: 0.00
- Maximum pit depth: 8.50 mils

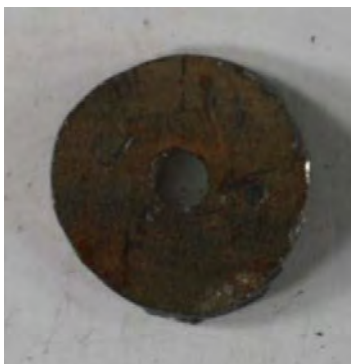
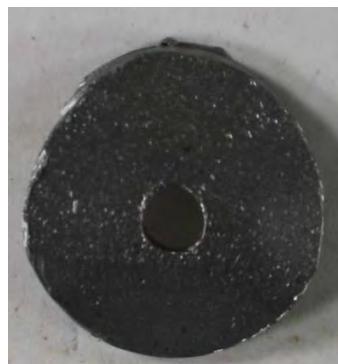
WATER SIDE ALUMINUM COATING DATA:

- Surface area coated: 0%
- Minimum thickness: 0.00
- Maximum thickness: 0.00
- Maximum pit depth: 5.21 mils

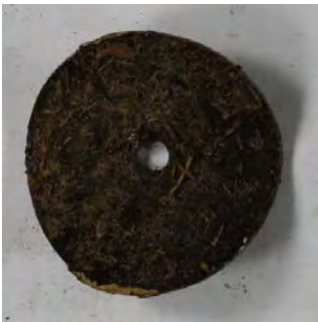
SOIL SIDE ALUMINUM COATING DATA:

- Surface area coated: 100%
- Minimum thickness: 1.24 mils
- Maximum thickness: 2.32 mils (60 µm)
- Maximum pit depth: 1.21 mils

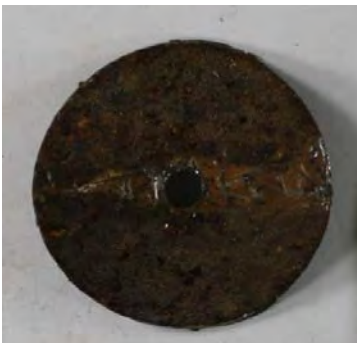
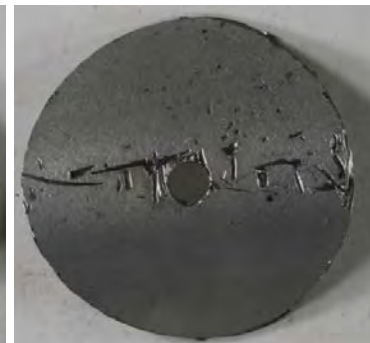
WATER SIDE ALUMINUM COATING DATA:

- Surface area coated: 100%
- Minimum thickness: 0.00 mils
- Maximum thickness: 3.68 mils (93 µm)
- Maximum pit depth: 4.31 mils

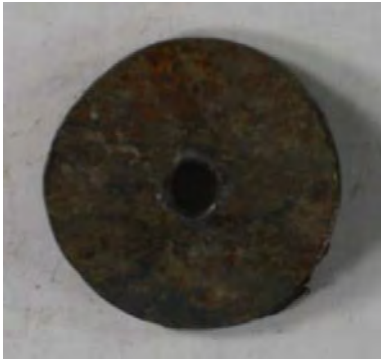
- Surface area coated: 40%
- Minimum thickness: 0.00 mils
- Maximum thickness: 0.89 mils (22.5 μm)
- Maximum pit depth: 2.57 mils

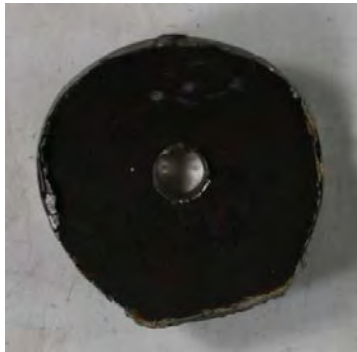
- Surface area coated: 100%
- Minimum thickness: 0.00 mils
- Maximum thickness: 2.53 mils (64 μm)
- Maximum pit depth: 1.97 mils

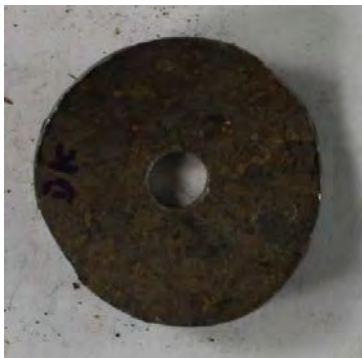
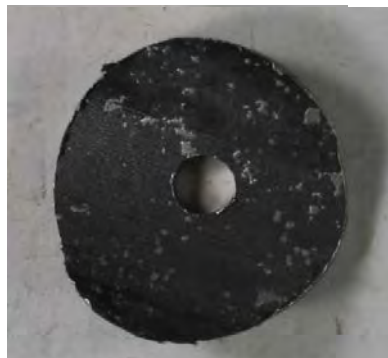
- Surface area coated: 5%
- Minimum thickness: 0.00 mils
- Maximum thickness: 0.00 mils
- Maximum pit depth: 0.73 mils

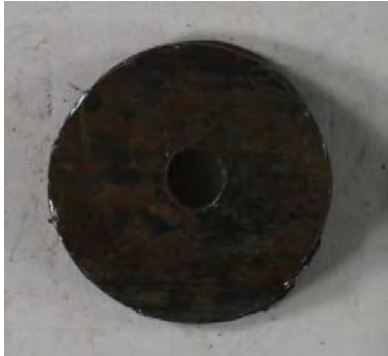
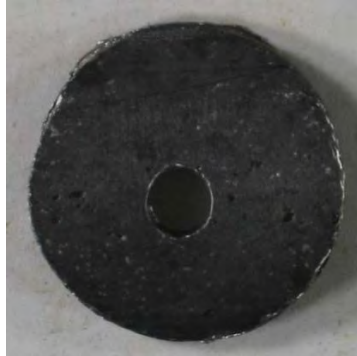
- Surface area coated: 5%
- Minimum thickness: 0.00 mils
- Maximum thickness: 0.00 mils
- Maximum pit depth: 12.00 mils

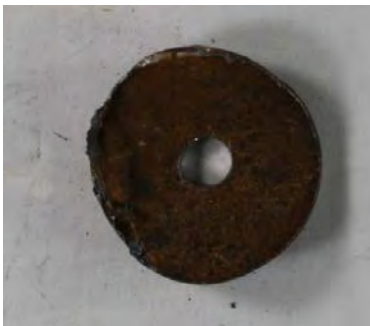
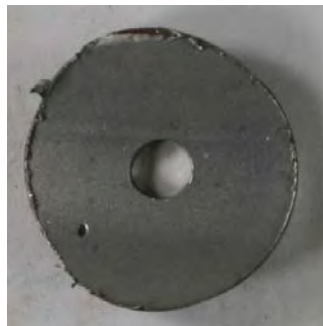
- Surface area coated: 100%
- Minimum thickness: 0.00
- Maximum thickness: 1.13 (29 μm)
- Maximum pit depth: 2.31 mils

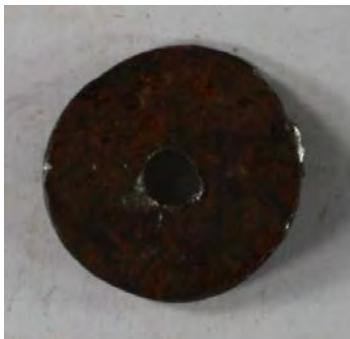
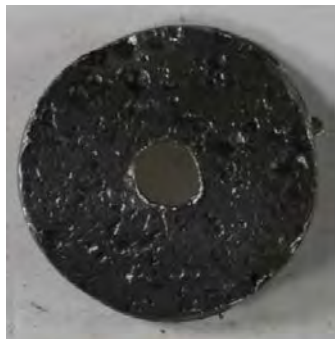
- Surface area coated: 0%
- Minimum thickness: 0.00
- Maximum thickness: 0.00
- Maximum pit depth: 41.00 mils

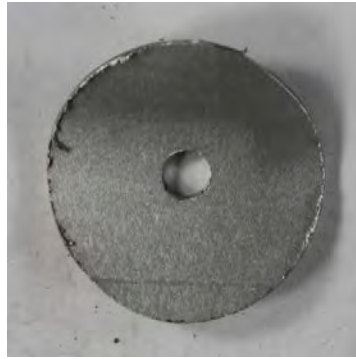
SOIL SIDE ALUMINUM COATING DATA:

- Surface area coated: 100%
- Minimum thickness: 0.55 mils
- Maximum thickness: 2.28 mils (58 μm)
- Maximum pit depth: 1.35 mils

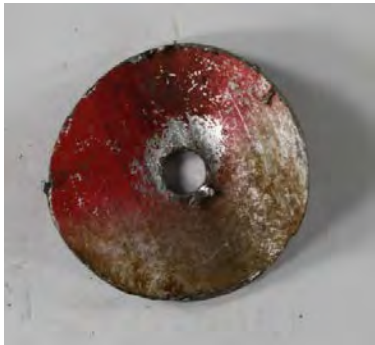
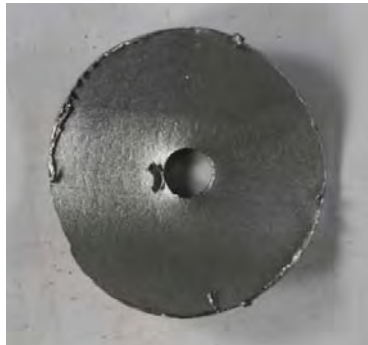
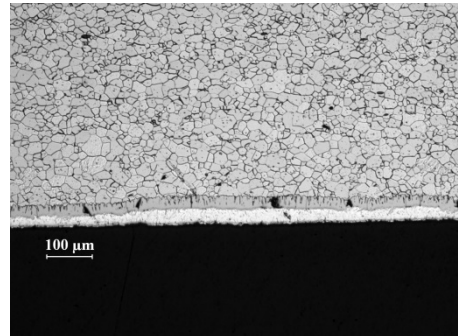
SOIL SIDE ALUMINUM COATING DATA:

- Surface area coated: 100%
- Minimum thickness: 1.00 mils
- Maximum thickness: 3.01 mils (76.5 μ m)
- Maximum pit depth: 0.87 mils

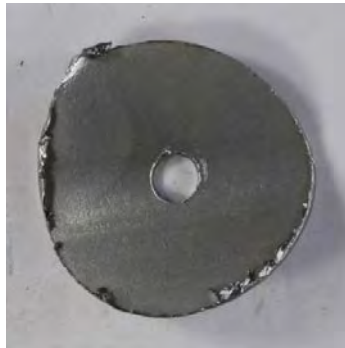
SOIL SIDE ALUMINUM COATING DATA:

- Surface area coated: 100%
- Minimum thickness: 0.87 mils
- Maximum thickness: 1.42 mils (36 μ m)
- Maximum pit depth: 3.38 mils

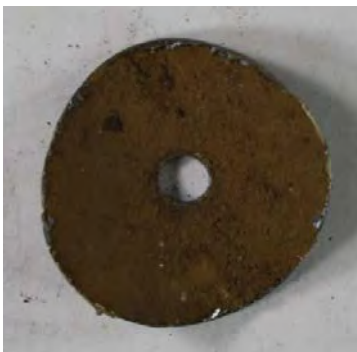
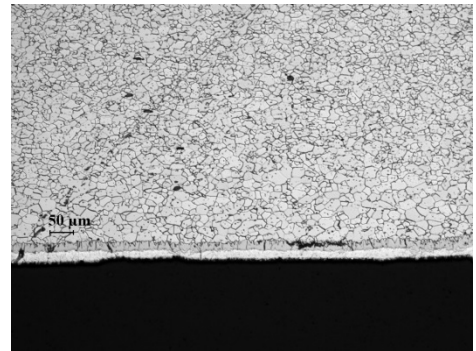
SOIL SIDE ALUMINUM COATING DATA:

- Surface area coated: 100%
- Minimum thickness: 0.55 mils
- Maximum thickness: 3.04 mils (77 μm)
- Maximum pit depth: 1.60 mils

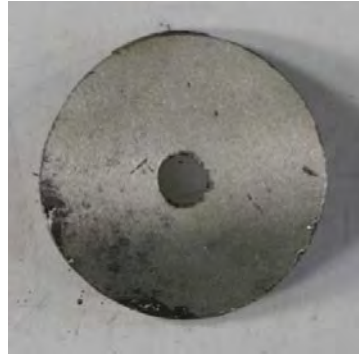
WATER SIDE ALUMINUM COATING DATA:

- Surface area coated: 95%
 - Minimum thickness: 0.37 mils
 - Maximum thickness: 1.584 mils (40 μm)
 - Maximum pit depth: 0.67 mils
- *Note: largest visible pit is a result of the removal process

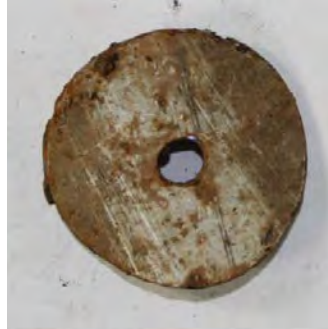
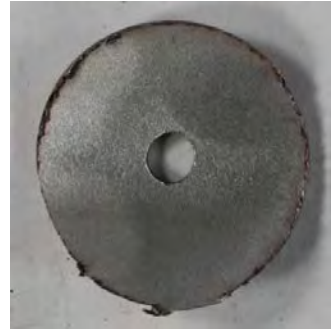
WATER SIDE ALUMINUM COATING DATA:

- Surface area coated: 95%
- Minimum thickness: 0.00 mils
- Maximum thickness: 2.03 mils (51.5 µm)
- Maximum pit depth: 9.00 mils
