JOINT LEAKAGE TESTING OF 24 INCH (0.6 M)
DIAMETER CORRUGATED STEEL PIPE UNDER
INTERNAL VACUUM

JOINT LEAKAGE TESTING OF 0.6M DIAMETER (24 INCH) CORRUGATED STEEL PIPE UNDER INTERNAL VACUUM

Joint leakage testing of 0.6m diameter (24 inch) corrugated steel pipe under internal vacuum

Conducted: December 8th and 9th, 2015

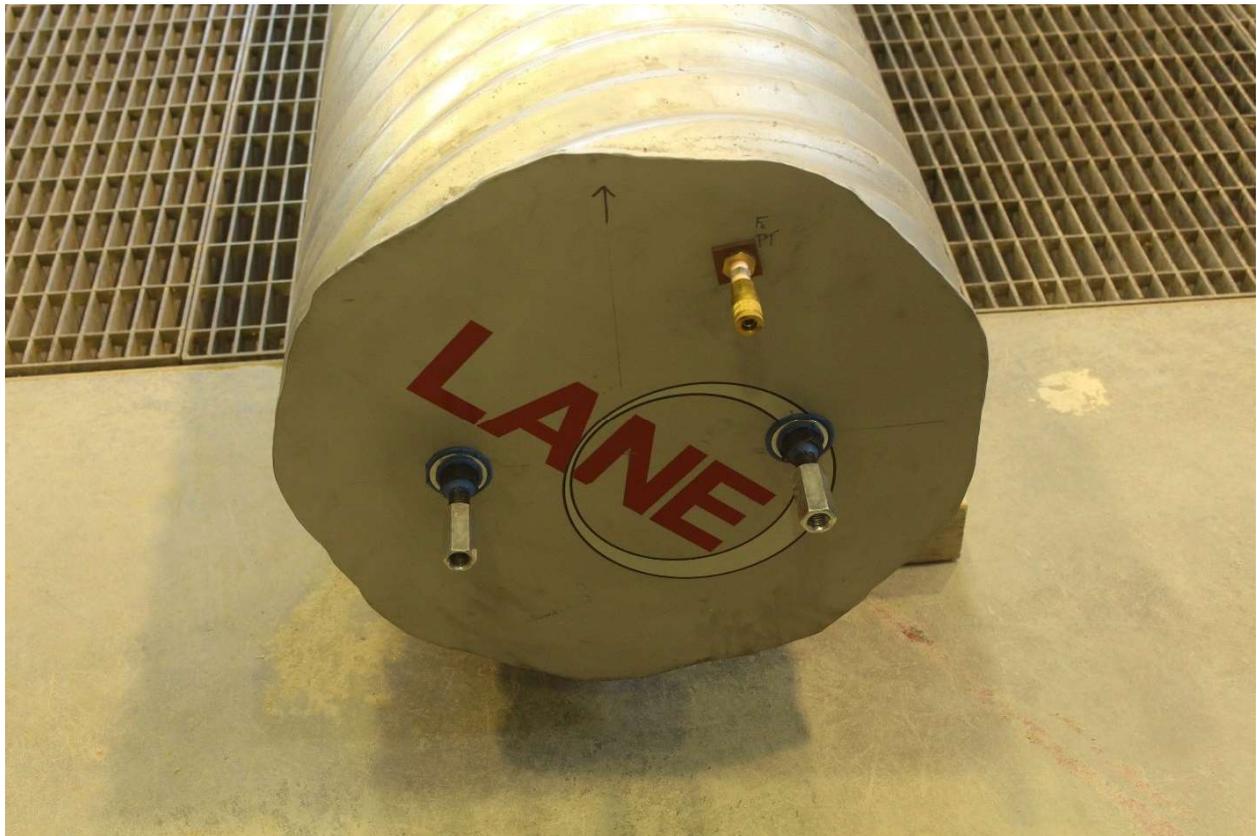
Figure 1. End-plate and pressure fittings on one of the corrugated steel pipe test samples.

Tests were conducted at Queen's University to examine the leakage of band connections in corrugated steel pipes. Specimens of 24 inch diameter gage 16 corrugated steel pipe were connected and tested under internal vacuum (i.e. external air pressure). Specimens had welded lock-seams, and were fitted with steel bulkheads, Figure 1. Gaskets meeting ASTM D1056, and 3/8" thick were employed, together with hugger and fully corrugated bands. Initial testing was undertaken for the pipes in straight alignment, and then one of the specimens was tested under three different loading scenarios using the pipe joint test frame developed at Queen's under NCHRP Project 20-07 Task 347 (Moore and Becerril García, 2015).

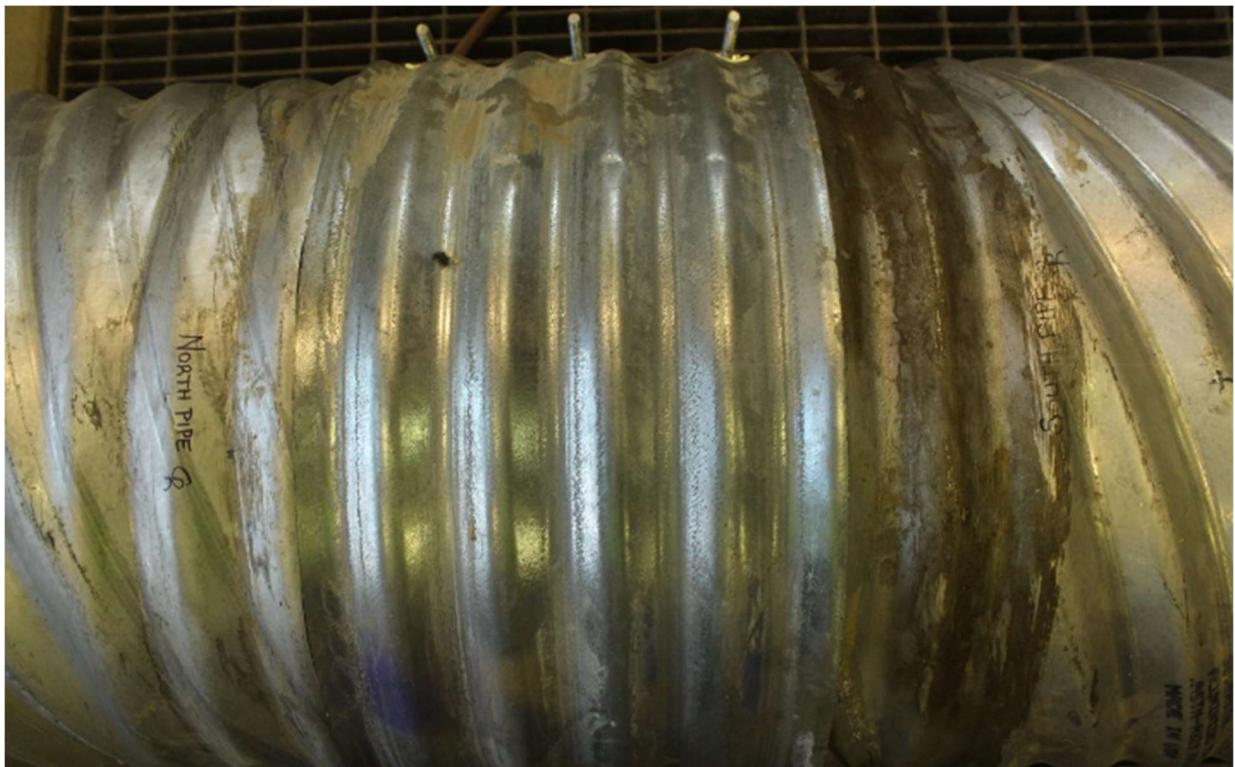
Figure 2. Corrugated band connection after assembly.

1. Five tests were conducted for the first configuration, Tests 1A to 1E, where a corrugated band joint was used with 3/8 inch thick sleeve gasket, Figures 2 and 3. Prior to placement of the sleeve, it was found that by placing geogrid across the joint between the ends of the two pipes being connected, Figure 4, the gasket was able to withstand the impact of the external air pressures that result from the internal vacuum.
2. Two tests were conducted for the second configuration, Tests 2A and 2B, where a hugger band joint was used with 3/8 inch thick sleeve gasket, Figure 5. Prior to placement of the sleeve, the same geogrid was placed across the joint between the ends of the two pipes being connected.

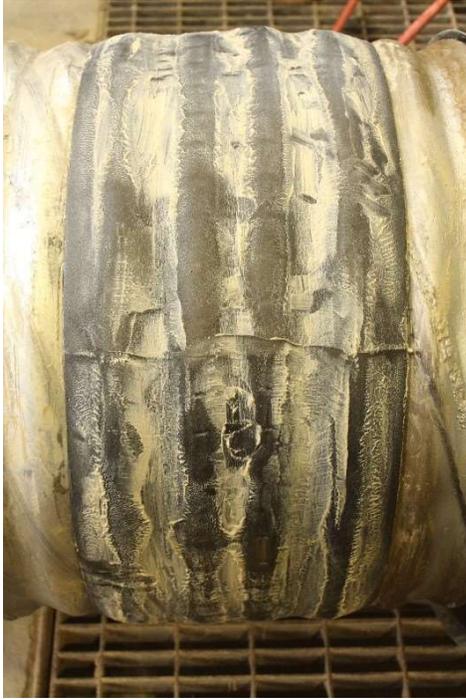
Figure 3. 3/8 inch sleeve gasket in place and lubricated prior to placement of the band.

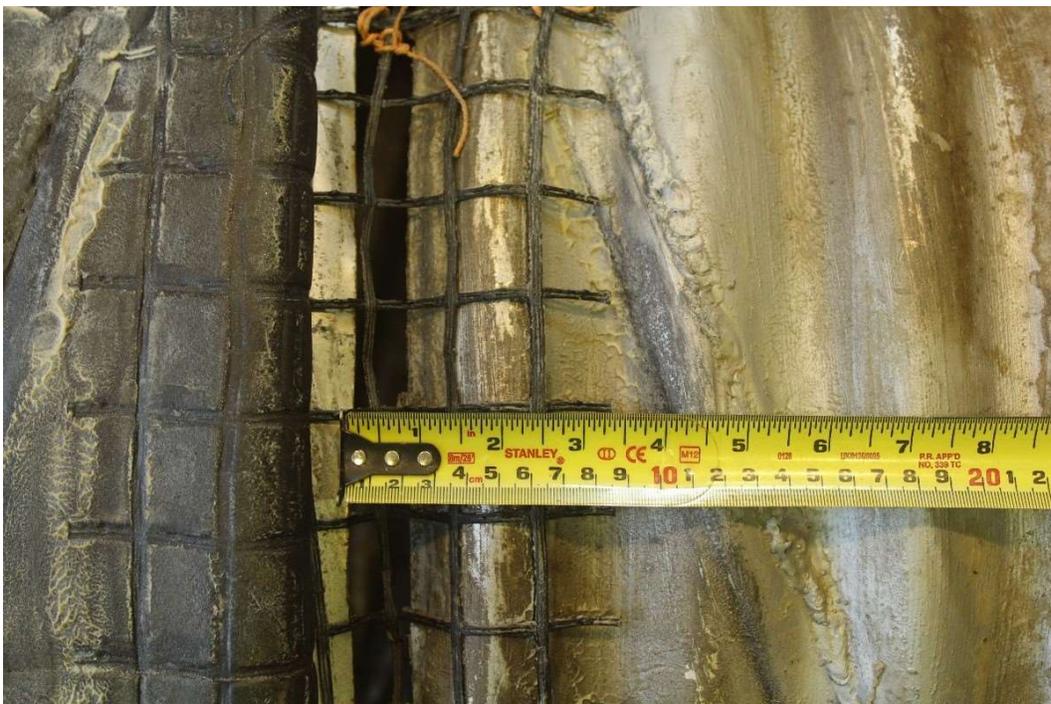
Figure 4. Geogrid in position after band and sleeve were removed after testing.

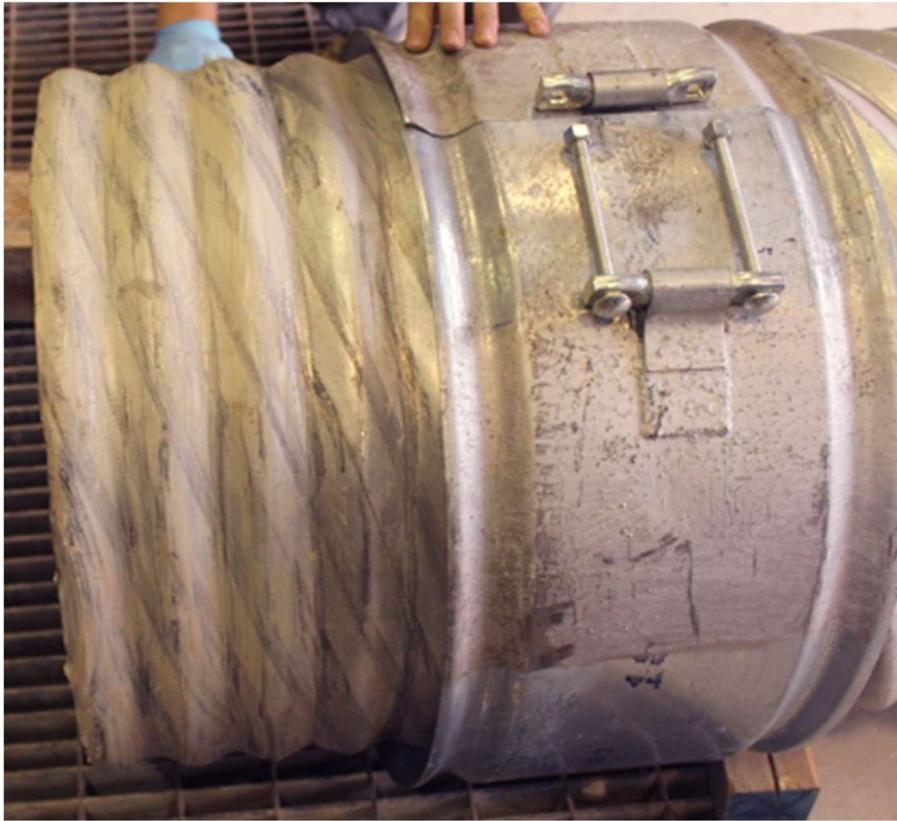
Figure 5. Hugger band and one of the rerolled pipe ends after lubrication (prior to placement of the 3/8 inch gasket).

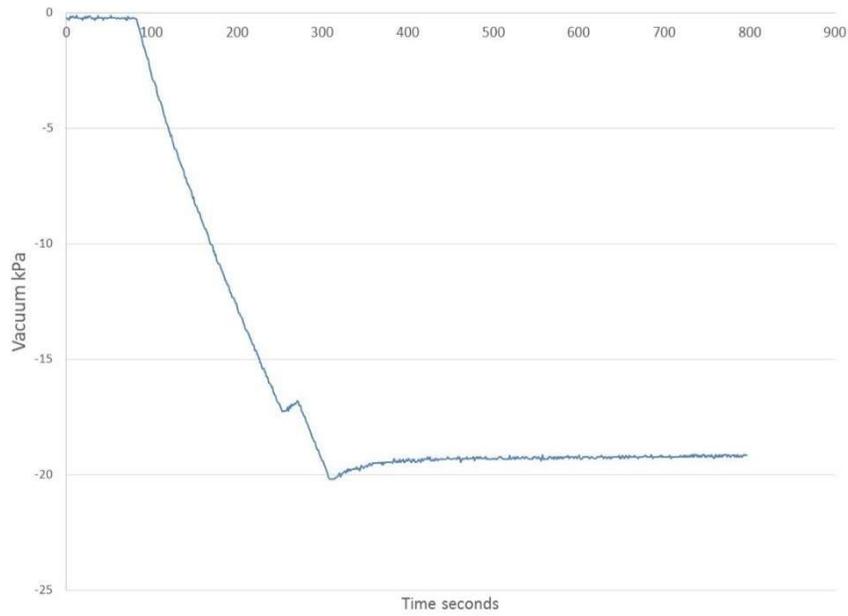
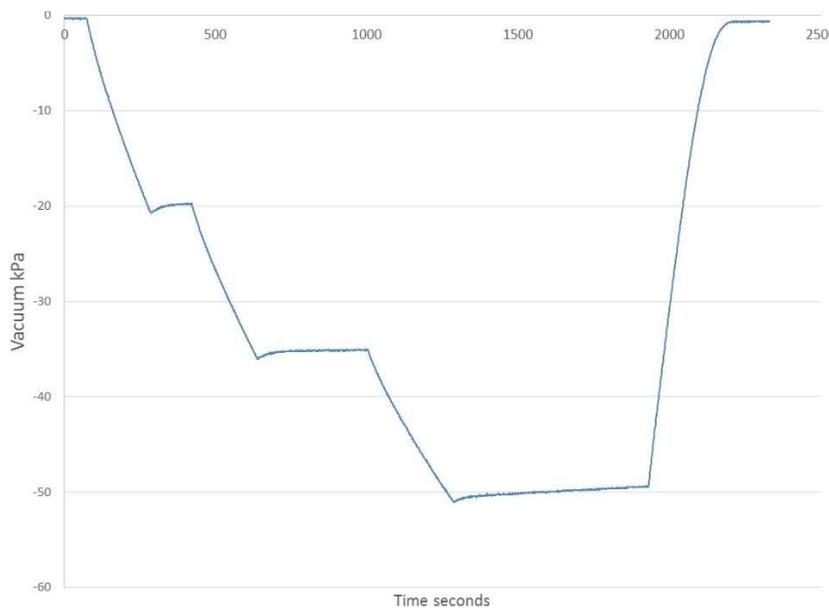
a. Pressure history for Test 1A conducted up to 20 kPa (3 psi) vacuum.

b. Pressure history for Test 1B conducted in three increments up to 50 kPa (7 psi) vacuum

Figure 6. Pressure histories recorded during the first two tests on the corrugated band joint.

Tests 1A, 1B, 2A and 2B were undertaken in that sequence, where the pipes were assembled on the main floor of the GeoEngineering Laboratory (not in the joint testing frame), and internal vacuum of 20 kPa (3 psi) or 50 kPa (7 psi) was applied. This was the maximum pressure attainable with the laboratory equipment. Changes in that pressure were then observed over time, as shown in Figures 6a and 6b and 7a and 7b for the corrugated and hugger bands, respectively.

Each of these pressure histories indicates that there is some reduction in pressure immediately after each increment in vacuum is applied, and then slow decreases in pressure during the remainder of the test. Joint leakage in previous experiments (Moore and Becerril García, 2015) is evidenced by sudden and significant decreases in pressure. Likely the initial loss and slow subsequent reductions are associated with compliance in the joint system (e.g. time dependent response of the gasket or geogrid), and are not indicative of any joint leakage.

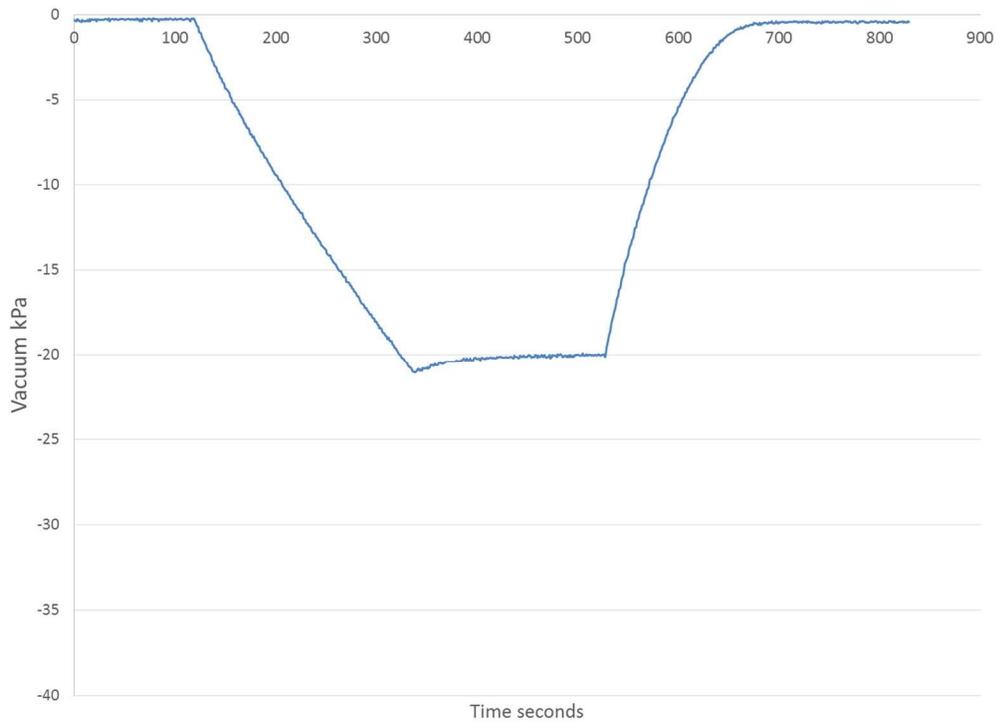
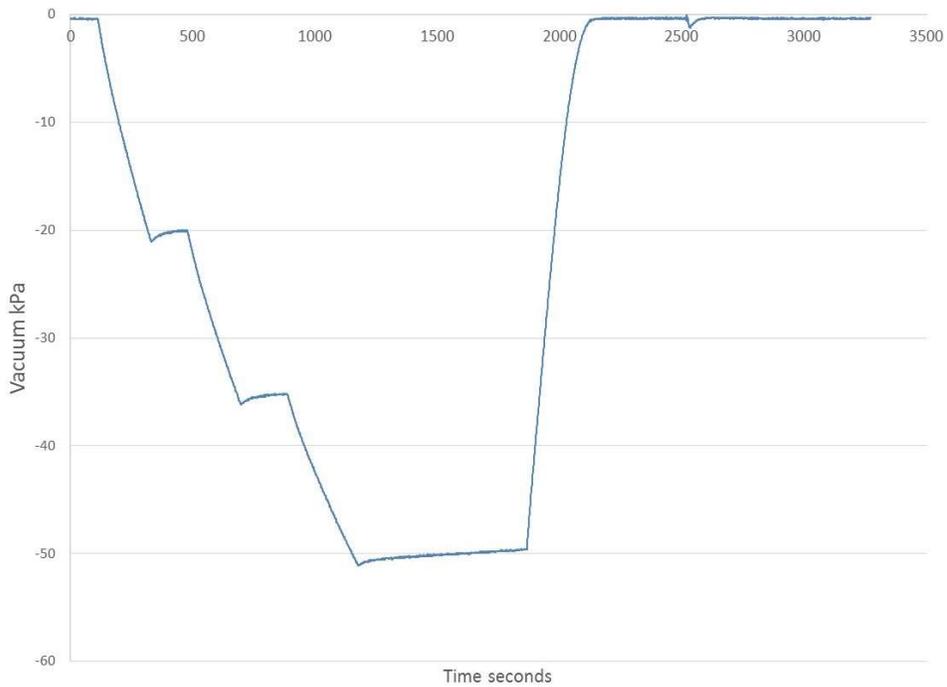
a. Pressure history for Test 1A conducted up to 20 kPa (3 psi) vacuum.

b. Pressure history for Test 1B conducted in three increments up to 50 kPa (7 psi) vacuum

Figure 7. Pressure histories recorded during the first two tests on the hugger band joint.

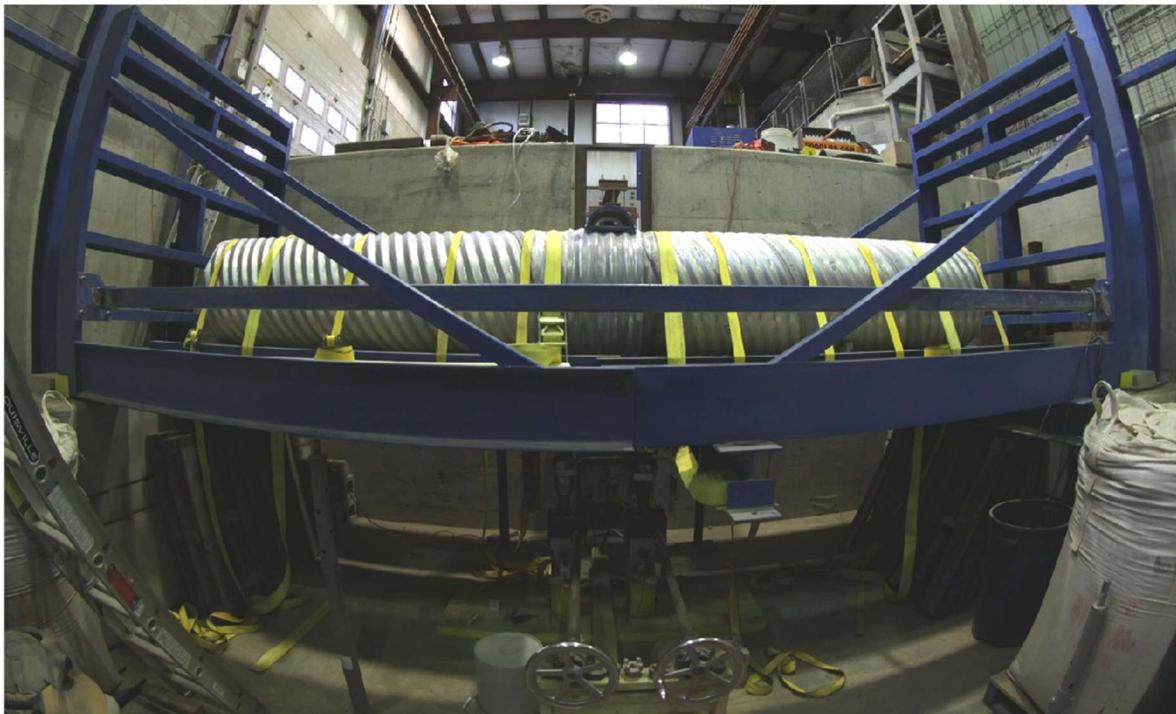
Figure 8. The two pipes connected with the corrugated band are strapped onto the Pipe Joint Testing Frame; this photograph was taken during preparation for test 1E before application of ovaling deflection or shear force.

Figures 8 and 9 show the test pipes with the joint assembled, mounted in the Joint Testing Frame. Both images were taken using a fisheye lens so as to capture the outer extremities of the testing frame, so straight lines are distorted in the images. Figure 8 is taken from the side, so the screw jacks and other testing apparatus can be seen. Figure 9 is taken from above, to show the yellow reaction beam installed over the crown (so that jack extension leads to ovaling deflection).

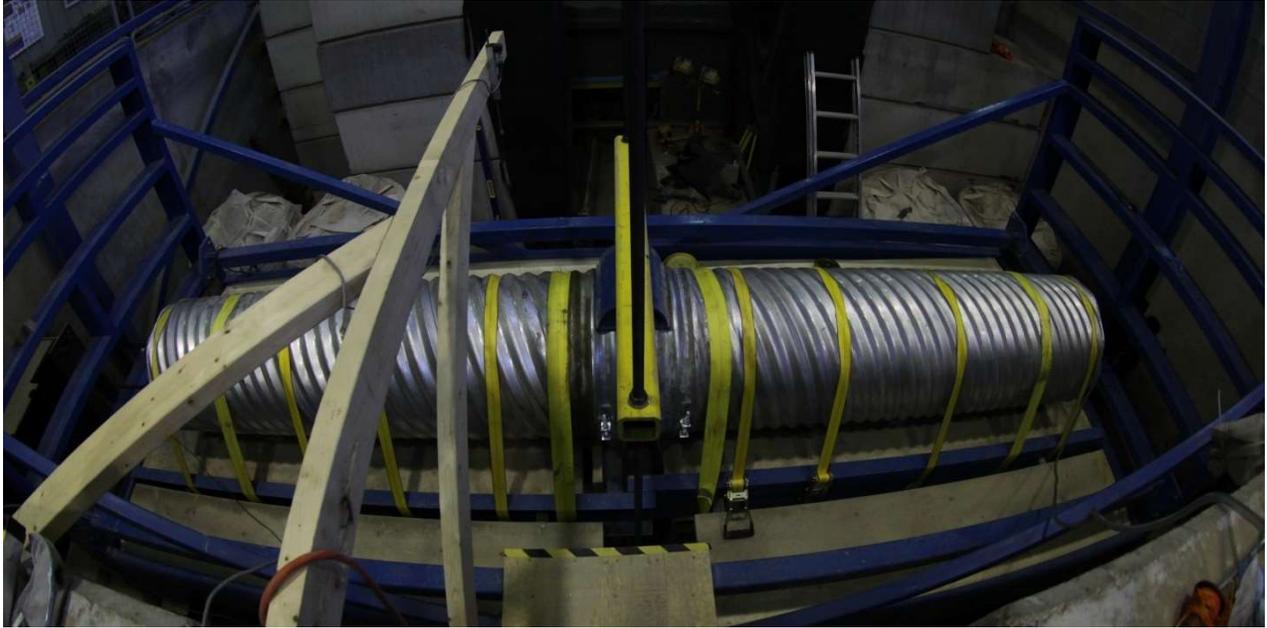
Figure 9. The two pipes connected with the corrugated band are shown during testing in the Pipe Joint Testing Frame; this was for test 1E under ovaling deflection; yellow beam acts to hold the top of the joint stationary so as the joint frame is raised (by extending the screw jacks), an ovaling deflection is imposed across the band and the pipes within.

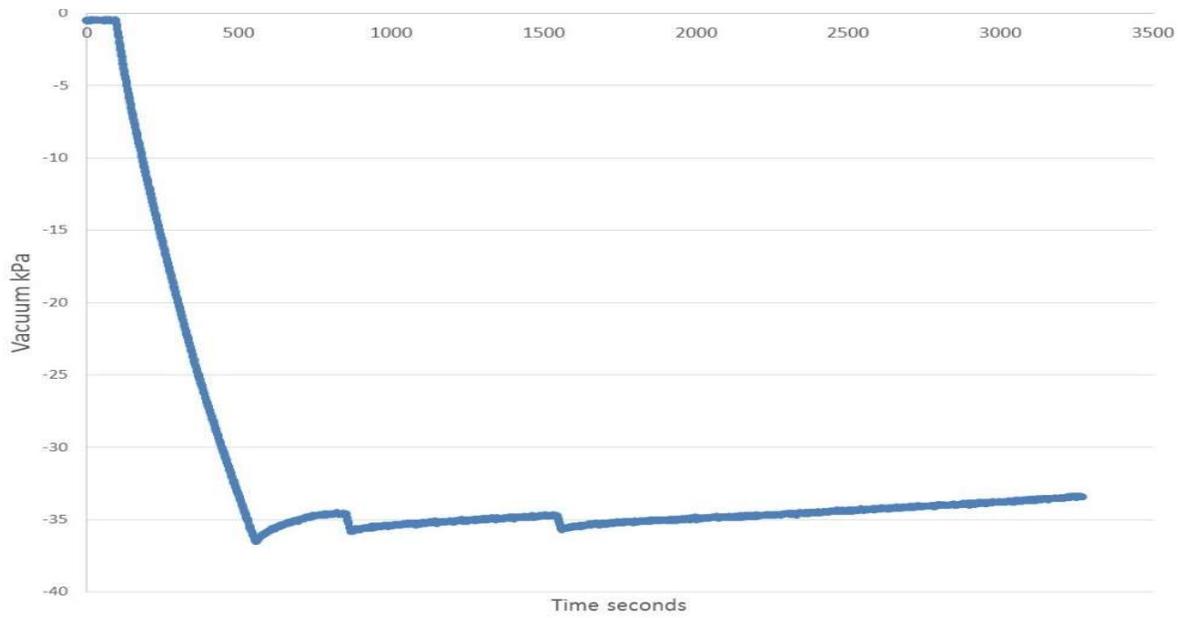
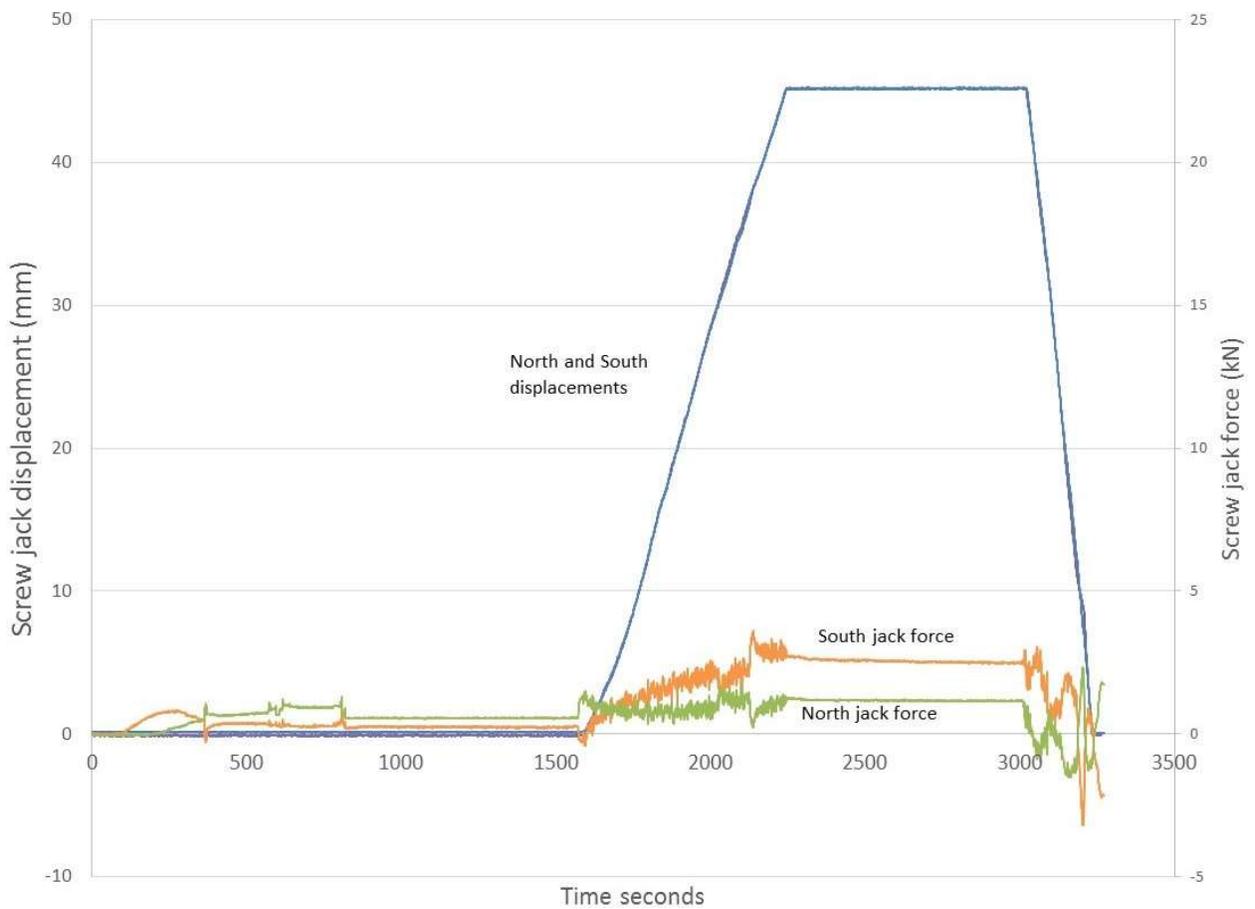
a. Pressure history.

b. Load and deflection histories.

Figure 10. Data recorded during Test 1C (rotation test conducted without shear force).

Figures 10, 11 and 12 present the pressure histories and the screw jack deformations and forces measured during Tests 1C to 1E, respectively.

For Test 1C, the two jacks were lifted together so a rotation was imposed across the joint. No leakage was detected up to and including this level of rotation, Figure 10a. As seen in Figure 10b, the total uplift deflection was 46 mm (1.8 inches), corresponding to a joint rotation of 2.1 degrees. Small changes in force were recorded in the load cells mounted to the screw jacks, with differences between them of magnitude 3.0 kN (370 lbs). This means that small shear forces (magnitude of 1.5 kN, 330 lbs) developed across the joint during testing.

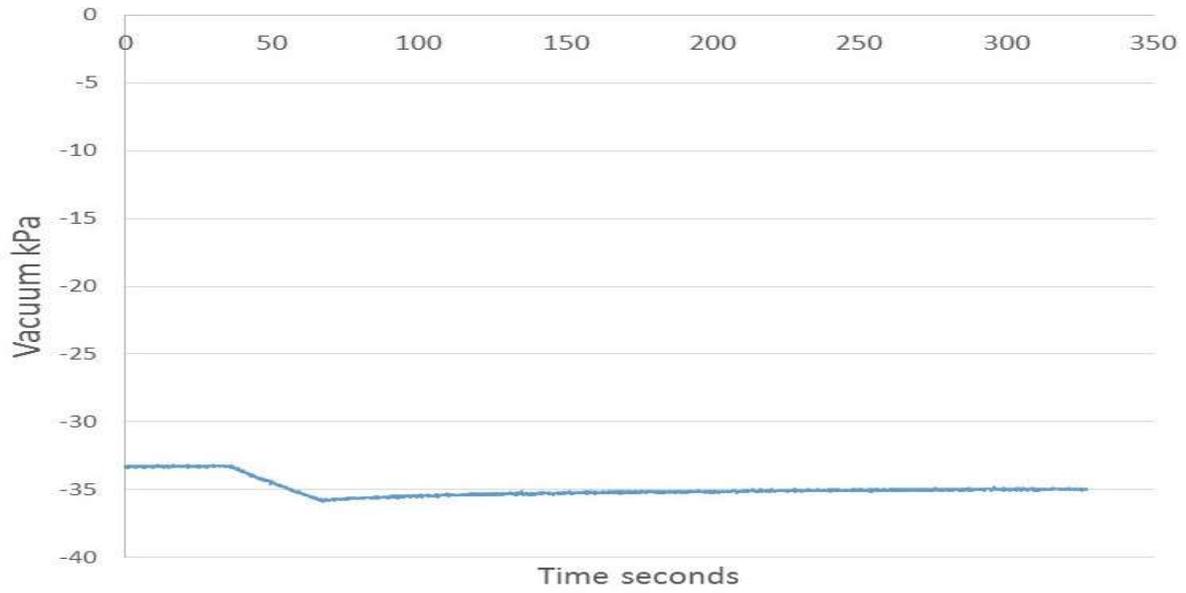
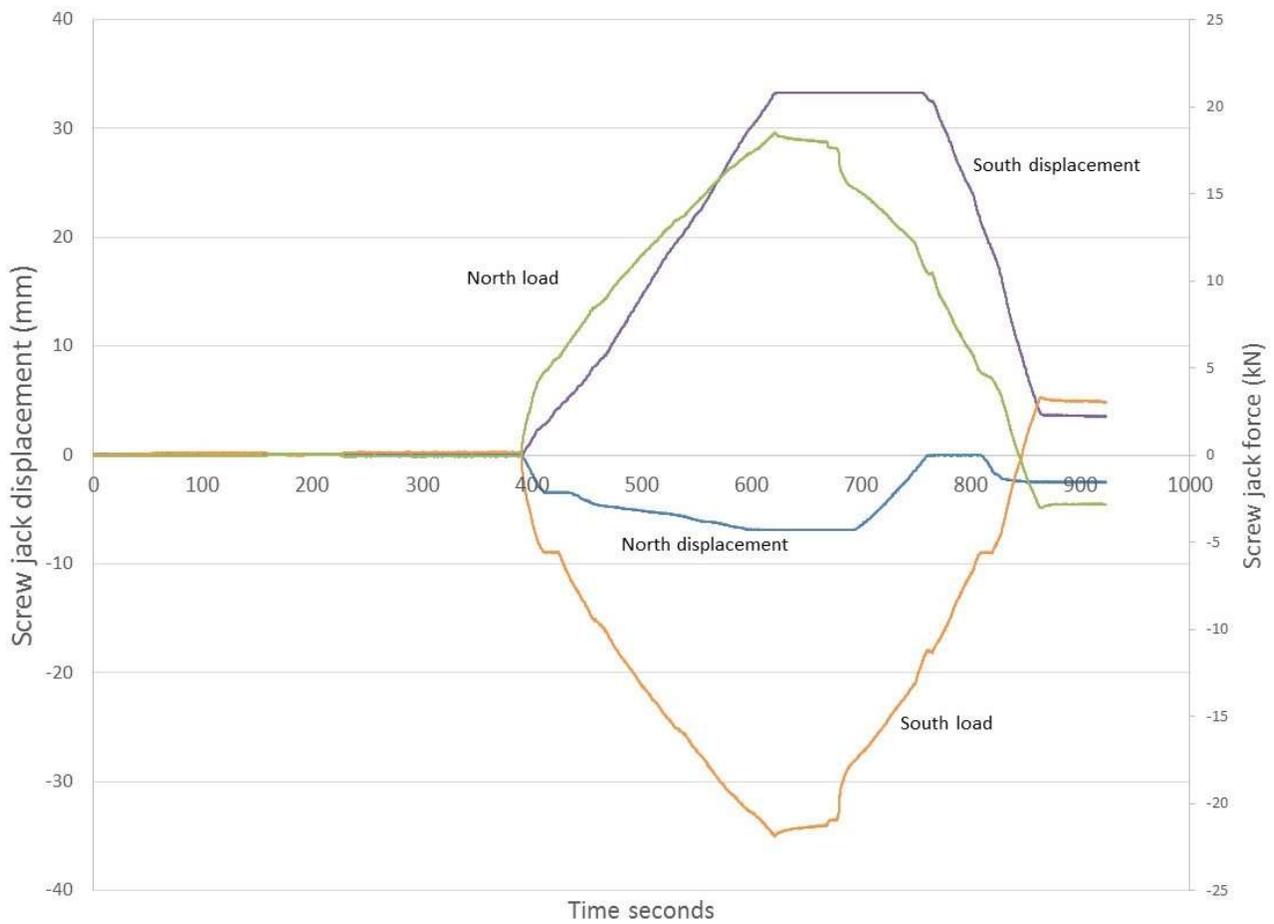
a. Pressure history.

b. Load and deflection histories.

Figure 11. Data recorded during Test 1D (test conducted in straight alignment under shear force)

For Test 1D, the two jacks were moved in opposite directions, so that a pure shear force was applied across the joint. Once again, the record of pressure with time (Figure 11a) shows no leakage at magnitudes of applied shear force of up to 20 kN (4500 lbs), Figure 11b.

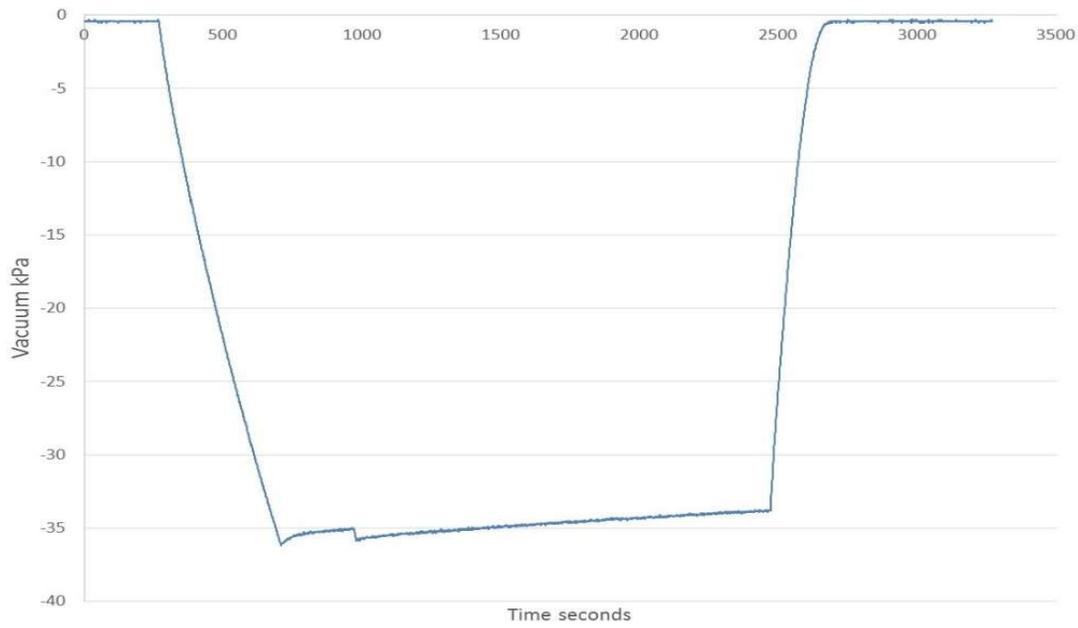
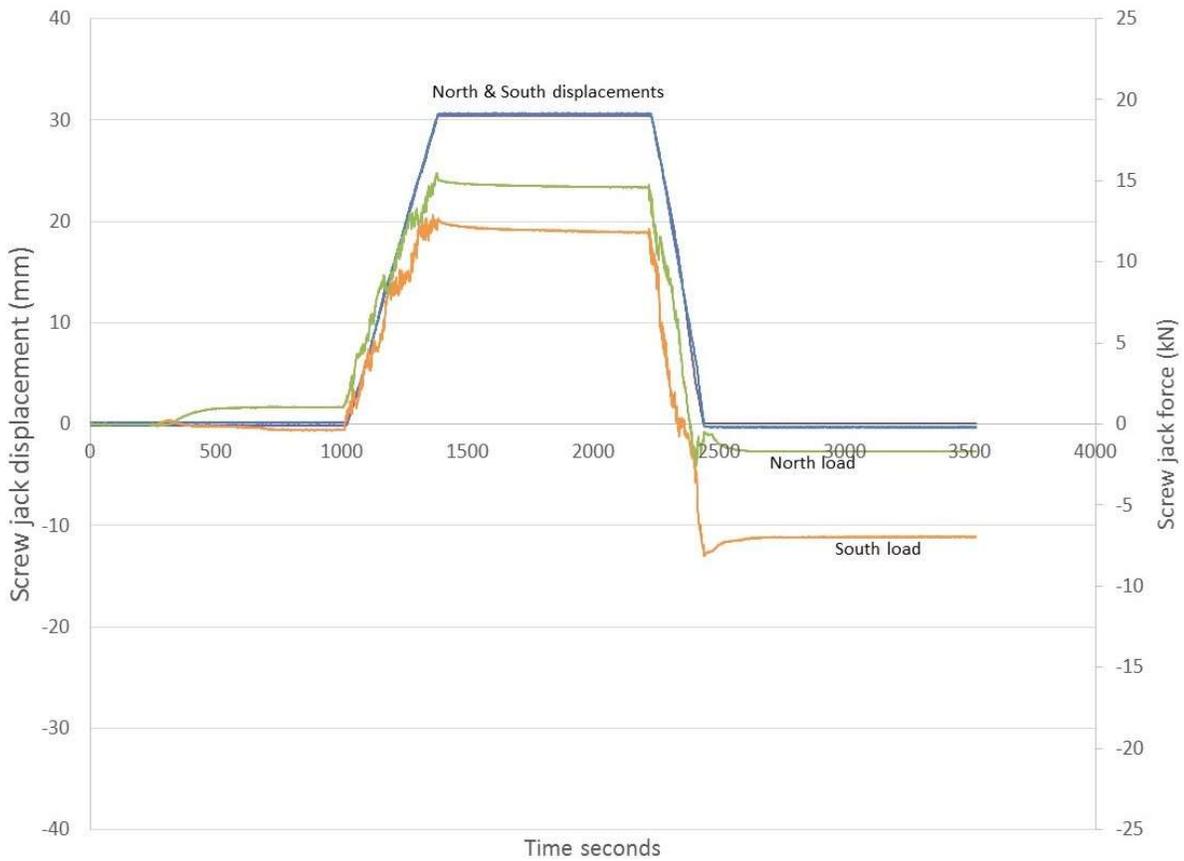
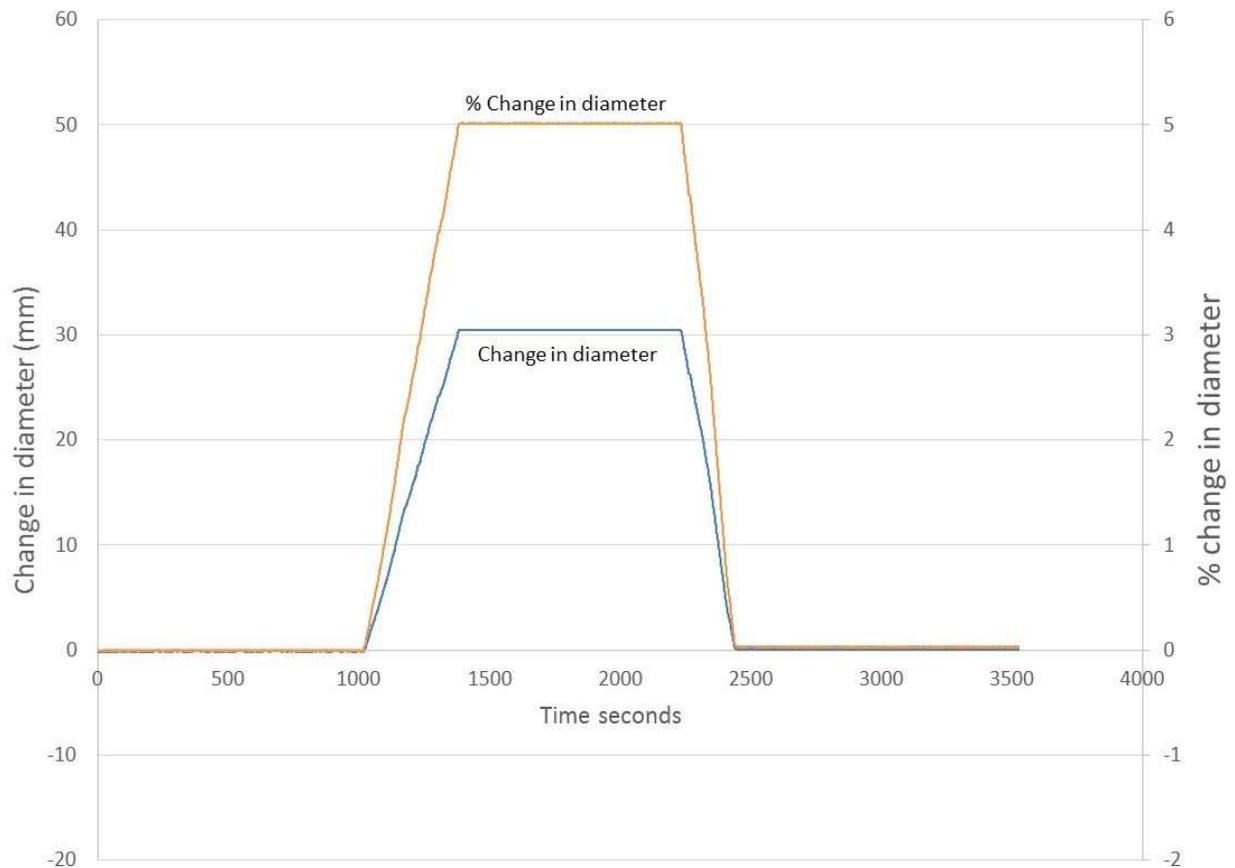
a. Pressure history.

b. Load and deflection histories.

Figure 12. Data recorded during Test 1E (test conducted with joint under ovaling deflection)

c. Imposition of ovaling deflection.

Figure 12 (cont'd). Data recorded during Test 1E (test conducted with joint under ovaling deflection)

Finally, for Test 1E, the yellow reaction beam seen in Figure 10 was placed over the top of the band. No leakage is seen in the pressure history (Figure 12a) as the two screw jacks were lifted by 30 mm (1.2 inches), to raise the invert of the two pipes (Figure 12b) and impose a vertical diameter decrease of 5% (Figure 12c).
