Invert Abrasion Testing of CSP Coatings

Prepared for:
NATIONAL
CORRUGATED STEEL
PIPE ASSOCIATION
March 2002

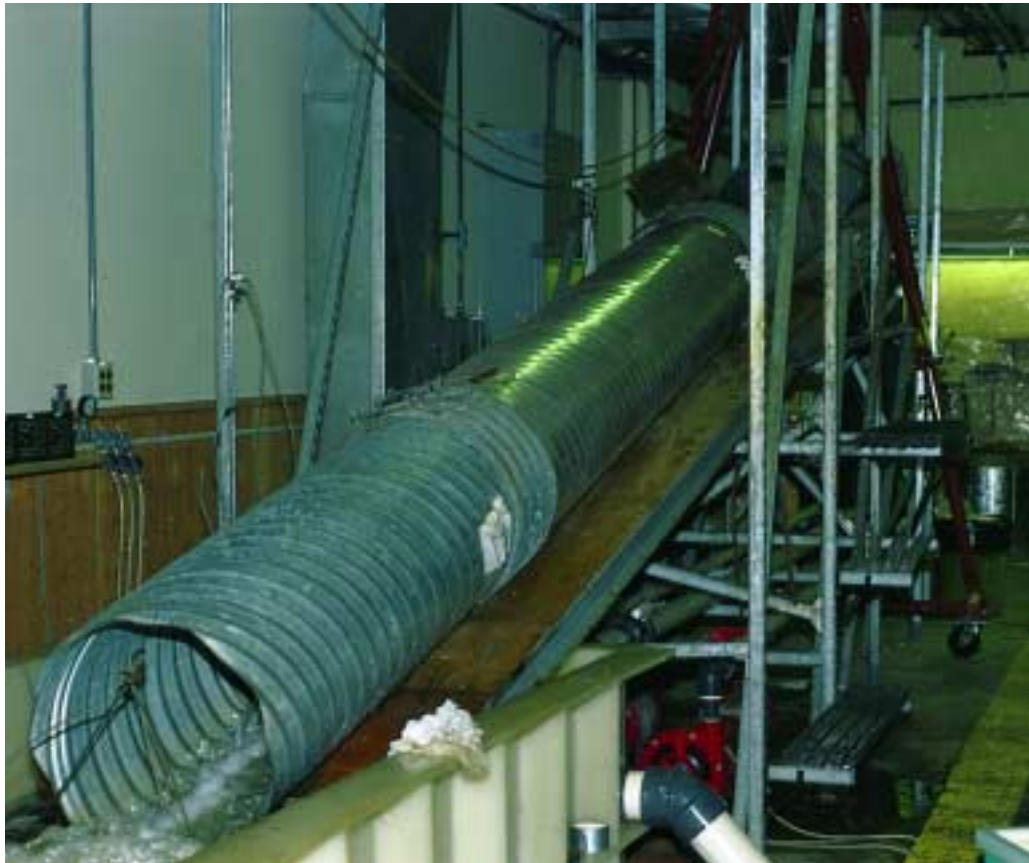
FIGURE 1A. Accelerated Abrasion Test Apparatus.

Figures 1A and 1B show a photograph and a design drawing of the accelerated abrasion test apparatus. The apparatus design considers the simulation of water velocities and bedloads established through the experience of others as deleterious to the performance of asphalt coated CSP. In the test rig, seawater is drawn through the pumping manifolds to 4-inch PVC pipe, expanding to 12 inch PVC through a 90° elbow to a 5-foot length of horizontal PVC pipe. The water then flows into a 5-foot length of 12- to 18-inch transition section of galvanized CSP that connects to a second 5-foot length of CSP. This second pipe has an opening in its crown for the entrance of bedload material. In the standard test pro-

cedure, the next section is the 10-foot test section of CSP (with the test coating applied). The test section then connects to a 5-foot length of galvanized CSP that empties into a large plastic sump. For the purposes of the present testing, three five-foot “test sections” were used to maximize the amount of data that could be generated with each test run.

A hopper in the sump retains the discharged bedload material, preventing its entrance into the pumps. This hopper is connected to a hoist that then connects to rail assembly with rollers. The hoist and roller combination allows for the abrasive material to be dropped back through the rig. The pump manifolds are connected to the sump by 4-inch PVC pipe. Plastic lined pumps with plastic impellers and the use of PVC pipe leave the CSP as the only metallic components of the system with which the circulating water contacts. Provision is made, but not shown on the drawing, for continuous refreshment of the circulating water with fresh water, preventing unwanted increases in the circulating water temperature or changes in seawater chemistry. Three pumps circulate the seawater medium.

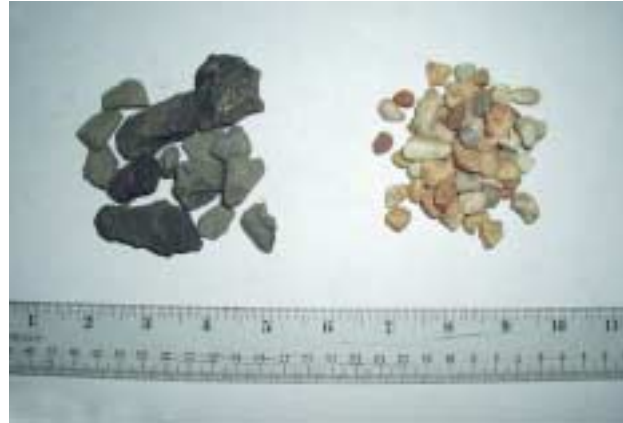
FIGURE 2. Bedload Materials ($\frac{3}{4}$ " trap rock on left, $\frac{3}{8}$ " local stone on right)

As can be seen in Table 1, there were two materials used for the bedload— $\frac{3}{4}$ " trap rock and a $\frac{3}{8}$ " local stone. **FIGURE 2** shows both materials. The $\frac{3}{4}$ " trap rock was the more severe of the two bedload materials because of size, angularity, and hardness of the material. It is commonly used as bed materials for railroads in the Eastern US. The $\frac{3}{8}$ " local stone is considered to be less severe because it is smaller, rounded, and softer stone. It has a variety of common uses including landscaping.

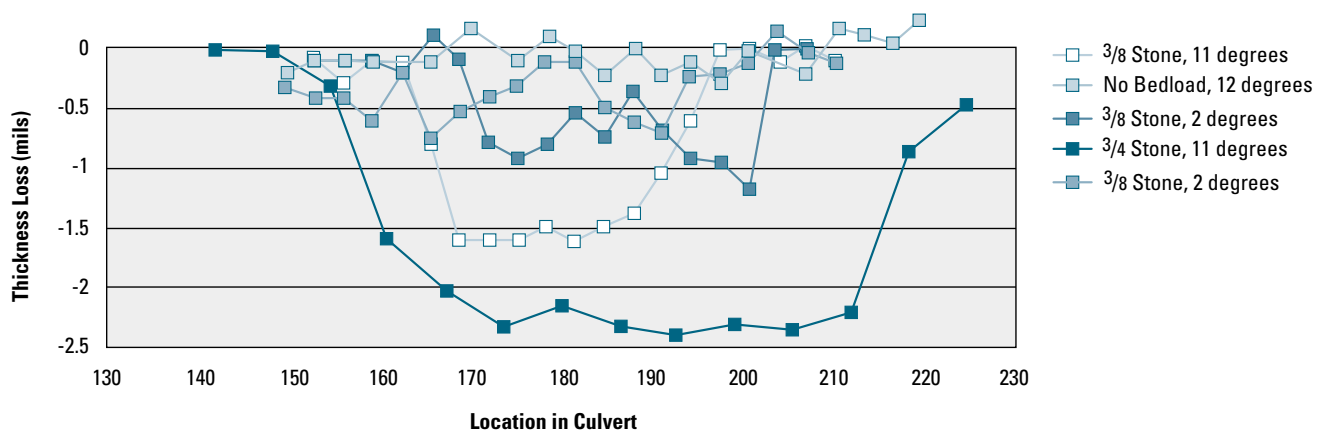
FIGURE 3. Galvanized Thickness Loss Under Different Test Conditions

FIGURE 3 shows the thickness of galvanizing before and after testing under the various abrasion conditions. This figure shows that the wear patterns of the galvanizing are similar for all stone sizes and angles of flow—that is, the wear is concentrated in the invert of the pipe. However, there is decreased wear at a smaller angle of flow than at the standard 12-degree angle. Furthermore, there is a decreased wear using the less severe bedload material even at the higher angle. It is difficult to differentiate between the relative effect of the bedload material and the pipe angle. Each of the changes appears to have a similar magnitude of reduction in the coating wear.

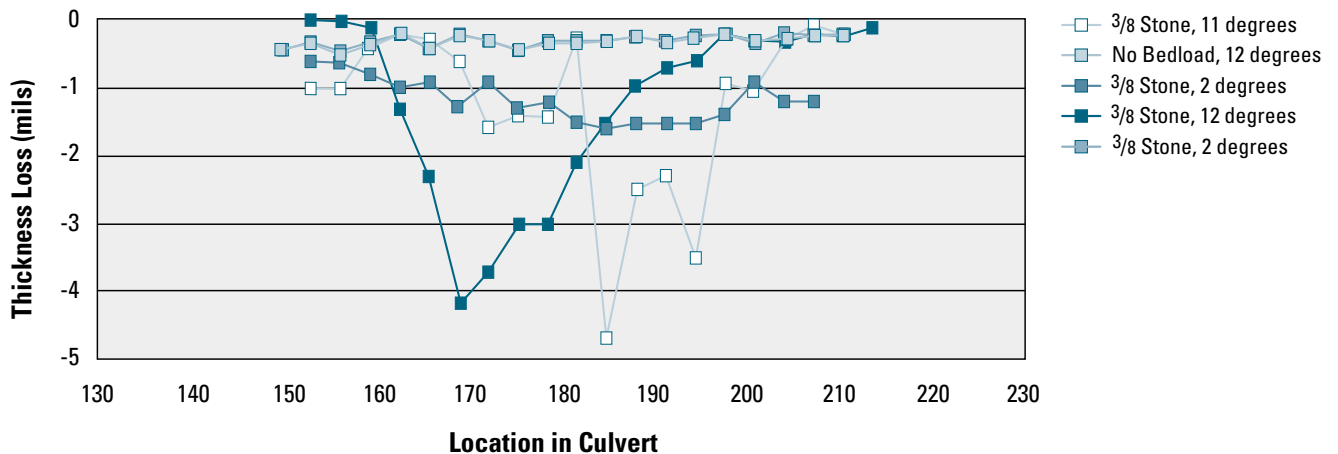
FIGURE 4. Polymer Precoat Thickness Loss Under Different Test Conditions

There was no exposed galvanizing after testing at either slope using the smaller bedload. **FIGURE 4** shows the thickness loss around the invert of the pipe for each of the tests. Notice that there is no data for the original test conditions ($\frac{3}{4}$ " Rock and 12 degree slope). We can deduce that the maximum coating loss for this condition was greater than 10 mils since exposed galvanizing was observed. The data suggest that at a lower flow angle the coating loss was more uniform across the bottom quadrant of the pipe section. However, at a higher flow angle the coating loss was much greater at the very bottom of the pipe than the loss at a 2-degree flow angle, even with the same bedload material. The data for the polymer precoat suggests that the impact of bedload material and pipe slope is similar in relative magnitude.

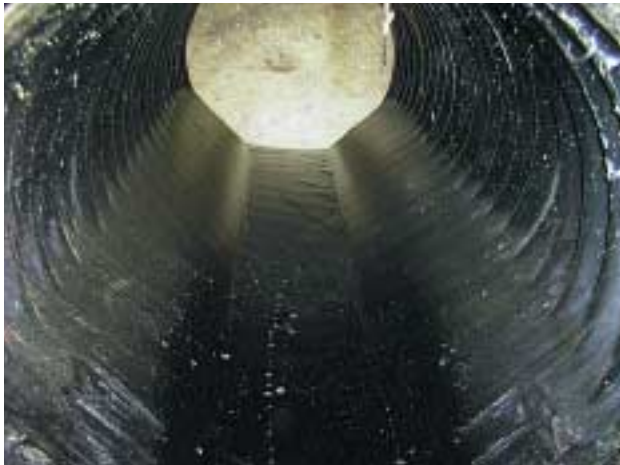
FIGURE 5. Asphalt paved pipe after test.

test conditions and results. **FIGURE 5** shows a photograph of the asphalt pipe after the testing. There was no exposed galvanizing after testing. Signs of wear were observed on the bottom (paved) section of the invert, characterized by a rough texture and extending 2-inches on either side of

the paved section. Remainder of asphalt coating is duller than original possibly indicating some wear of the coating. No detectable loss was observed after testing. It is important to note that the test does not consider the effect of aging on asphalt performance.

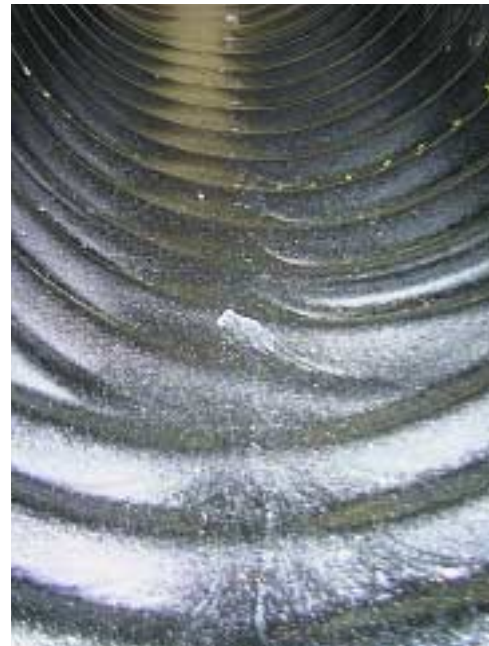
FIGURE 6. Polymerized asphalt over galvanizing after test run 3.

Two tests were run on G210 galvanized CSP with "Truflo" polymer modified asphalt. **TABLE 5** presents a summary of the test conditions and the results. **FIGURE 6** shows one of the areas where galvanized has been exposed on a corrugation after Test Run 3. **FIGURE 7** presents the measured thickness losses as a function of location in the invert. The data demonstrated the effect of different abrasive on the abrasion resistance of the material. Clearly the less severe abrasive resulted in less wear as measured both by thickness loss and by exposed galvanizing.

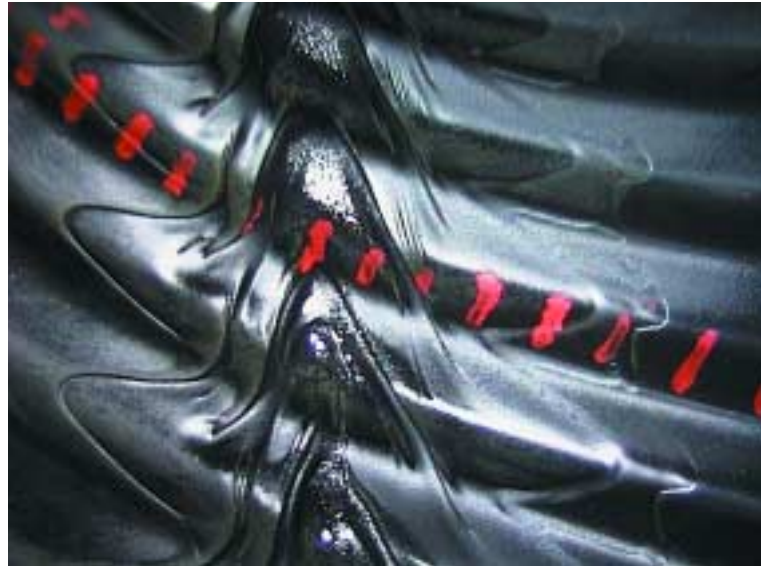
FIGURE 9. Polymer modified asphalt paved invert over Polymer Precoat after Test run 8.

The paved inverts showed the same cold flow phenomenon as was observed on the galvanized pipes. **FIGURE 9** shows an example of the cold flow on the polymer coated pipe from Test Run 8. Note that no galvanizing was exposed during either of these tests

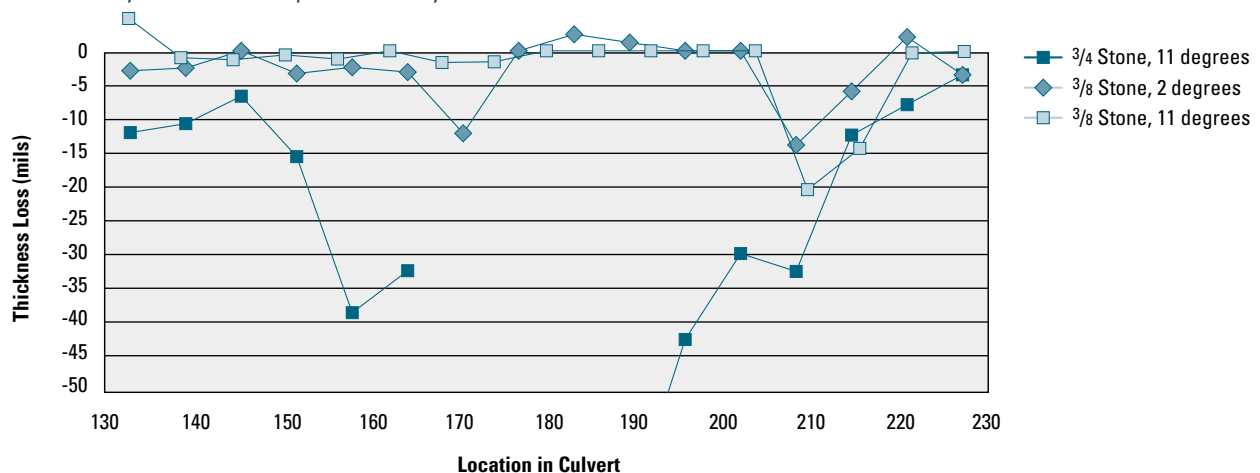
FIGURE 8. Polymer Modified Asphalt Over Polymer Precoat

FIGURE 8 shows the thickness loss of each of these coatings after the test.
