Out of Sight, Not Out of Mind **Heart Lake Storm Sewer Reline**

Owner: Ministry of Transportation Ontario
Consultant: Morrison Hershfield
Contractor: Underground Services Limited

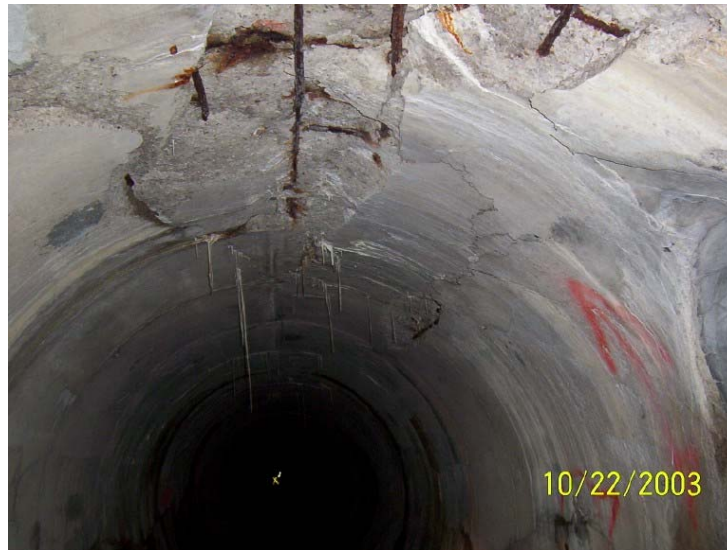
At the intersection of HWY 401, HWY 410 and HWY 403 some 321,000 vehicles pass every day. Under layers of intertwined bridge structures is the Heart Lake Storm Sewer. Built in 1980 this 3050 mm diameter reinforced concrete sewer was showing signs of serious deterioration. Large cracks were evident, the result of the rigid sewers inability to accommodate extreme pressures but relatively minor movement of the expanding shale bedrock. Corroded reinforcing steel was exposed at the top of the pipe. It was apparent that road salt was making its way into the concrete walls.

Cracked and Corroded Rigid Sewer Pipe

Replacing the sewer was not an option, nor was it an option to close your eyes and hope that all would be fine. Through an innovative relining technology, using Corrugated Steel Pipe, the MTO without fanfare, quietly fixed the problem.

The decision was made to reline the existing sewer and extend its life. The Consultant, Morrison Hershfield was charged with finding a system that would accommodate the expected loads and up to 90 mm of future shale bedrock expansion. The liner would also have to meet all of the physical and hydraulic constraints of the project.

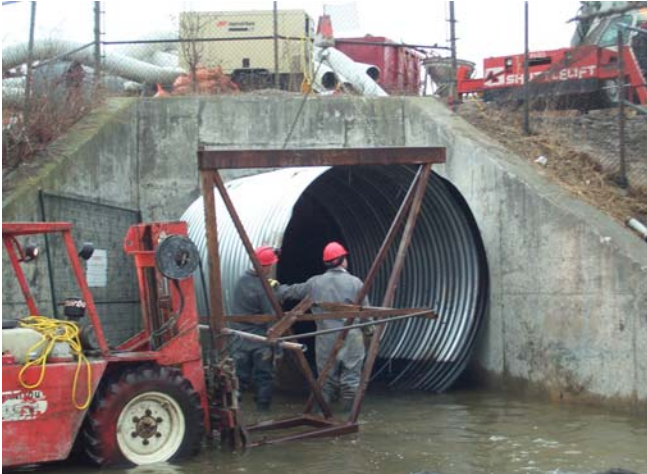
Fork Lift with Carrying Frame

The contractor, Underground Services, developed a special frame to carry the CSP liner sections into the sewer using a small fork lift truck. An innovative de-watering scheme proved to be cost efficient and highly effective, accelerating the progress of the project.

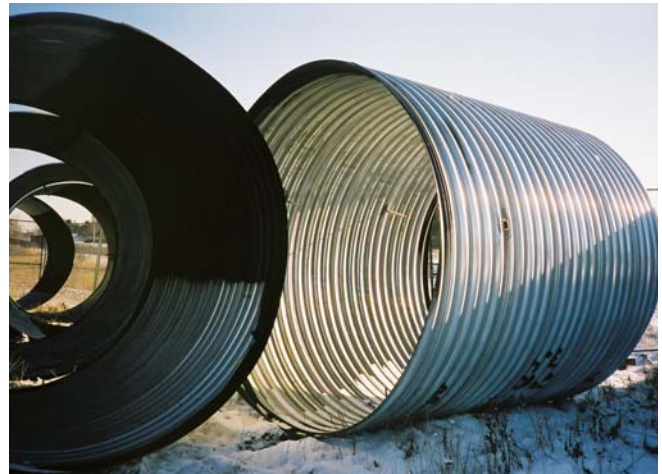
CSP with Screw Jacks and Grout Plugs

Each section of pipe had screw jacks fitted at the manufacturer's plant. These were required for accurate adjustment of line and grade prior to blocking and installation of internal coupling bands. Grout fittings in the liner walls allowed for controlled pumping of grout into the cavity between the liner and host pipe.
